# ATLAS T-240

Wear and deterioration inspection

DEMO-001

10 Feb 2026

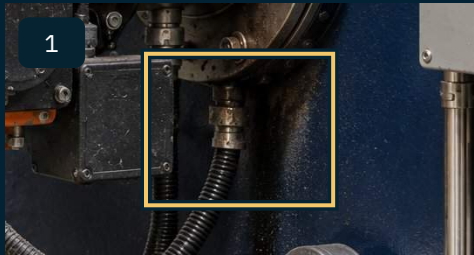
## 1 / Dark Streak Below Flange

Dark run-down staining beneath mounting flange

Dark streak/staining visible on the vessel wall beneath the mounting flange may indicate prior seepage or run-down of contamination. [MEDIUM]

Wipe down casing, investigate origin of dark streak beneath flange, and schedule internal burner inspection.

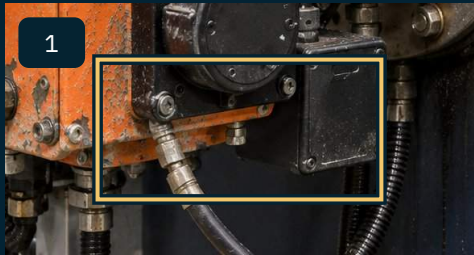
## 1 / Dark Streak Below Flange

Dark tracking beneath mounting flange, possible moisture path

Dark streak visible beneath the mounting flange consistent with technician observation, possibly moisture or fluid tracking. [MEDIUM]

Investigate flame-signal drop: clean/inspect flame scanner and lens, trace source of dark streak beneath flange, and schedule burner-side inspection.

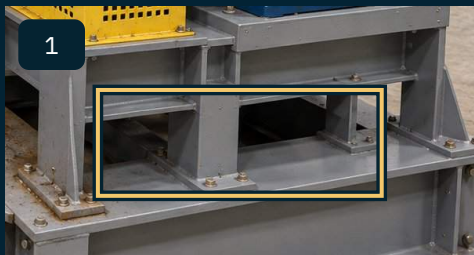
## 1 / Pedestal Debris Ring

Rust-colored debris around front hold-down base

Rust-colored debris accumulation ringing the front pedestal hold-down base [MEDIUM]

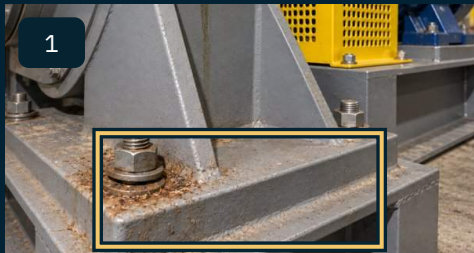
## 1 / Debris Ring At Bolt

Front pedestal shows a broad rust-colored debris ring around the hold-down bolt and a dark vertical streak down the housing web; measured vibration at this point has doubled to 6.2 mm/s RMS in mode M1. Internal bearing condition is not verified from this external view.

Rust-colored debris around front pedestal hold-down

Schedule bearing inspection and root-cause review of debris/streak; trend vibration and plan intrusive check before next run cycle.

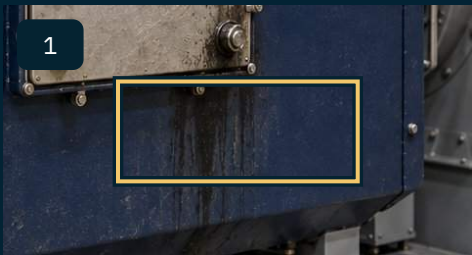
## 1 / Hatch Edge Leakage Track

Dark streak emerging from lower right hatch edge

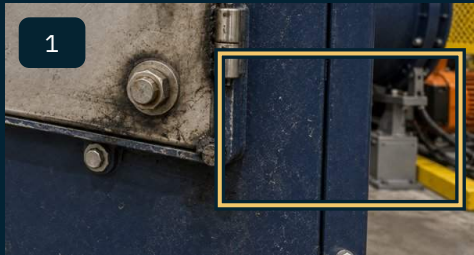
## 1 / Soot Track

Black leakage track from lower right hatch edge

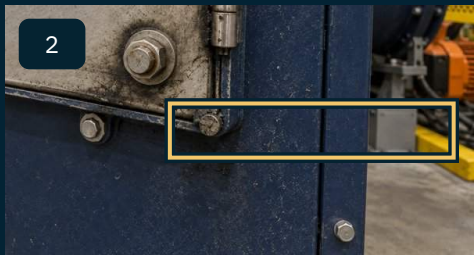
## 2 / Seal Line Staining

Soot deposit along hatch seal interface

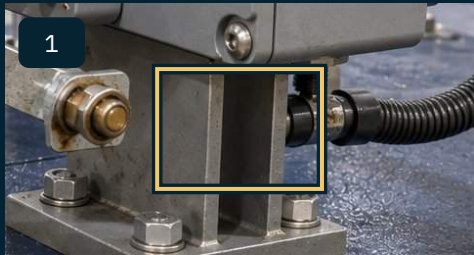
## 1 / Pivot Residue

Brown residue at linkage pivot bolt

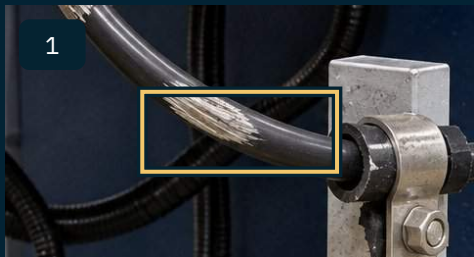
## 1 / Tubing Abrasion Patch

Bright wear scar where tubing rubs bracket

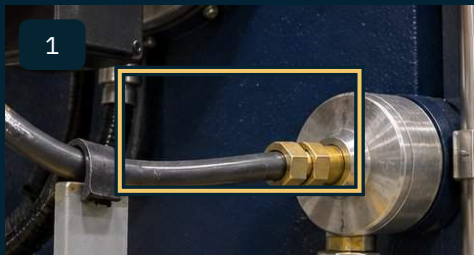
## 1 / Tubing Abrasion Patch

Bright wear mark where tubing contacts bracket

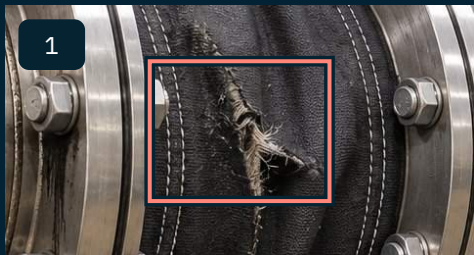
## 1 / Split Outer Fold

Flexible fabric connector between two flanged duct sections shows a torn outer fold with protruding fibers and a dark streak along the lower flange, consistent with the technician's observation of a split and possible leakage indication.

Torn fabric fold with protruding loose fibers.

Schedule replacement of the flexible connector and perform a leak test; inspect concealed inner fabric before return to service.

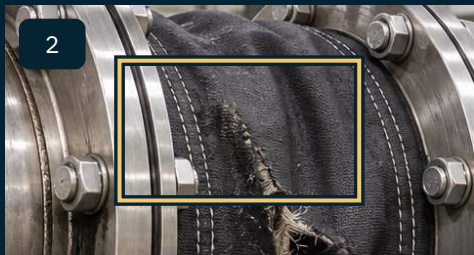
## 2 / Dark Streak

Discoloration below clamp edge suggests leakage tracking.

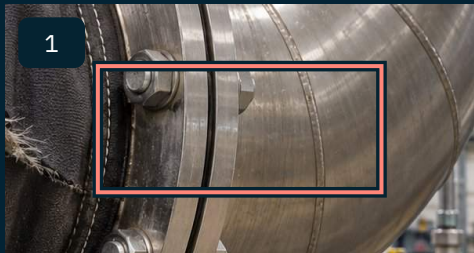
## 1 / Fabric Split

Flexible connector fabric between the two flanged duct sections shows a visible split in the outer fold with protruding loose fibers and a dark streak below the clamp, consistent with the technician's observation of active degradation.

Torn outer fold with protruding loose fibers

Schedule flexible connector replacement; perform leak check and inspect concealed circumference before continued service.

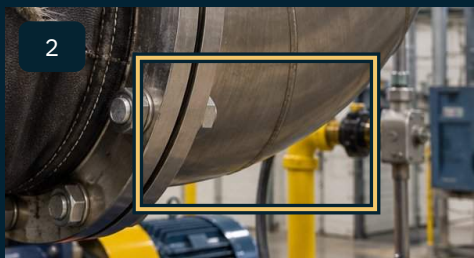
## 2 / Dark Streak

Discoloration below clamp suggesting leakage path

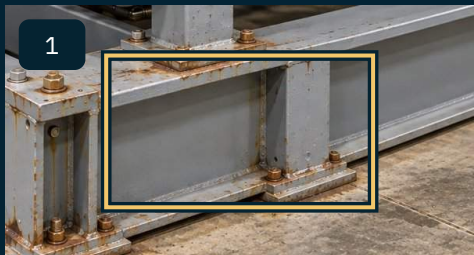
## 1 / Support Plate Corrosion

Flaking paint and rust on front gusset

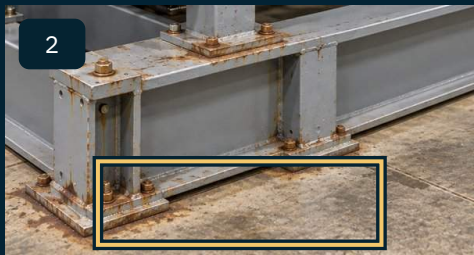
## 2 / Anchor Washer Staining

Rust staining around anchor bolts and washers

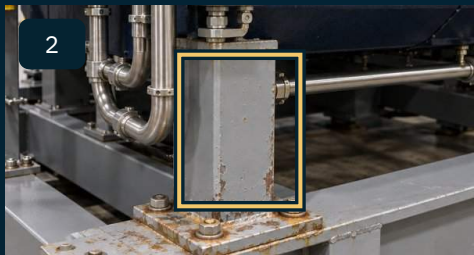
## 2 / Support Plate Flaking

Paint flaking and rust bloom on support column

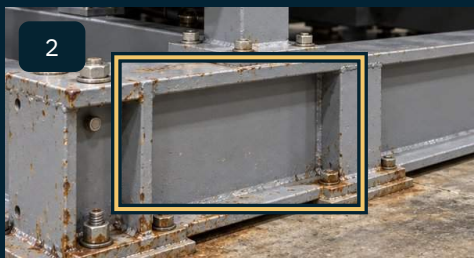
## 2 / Front Plate Rust

Flaking paint and rust bleed on support plate

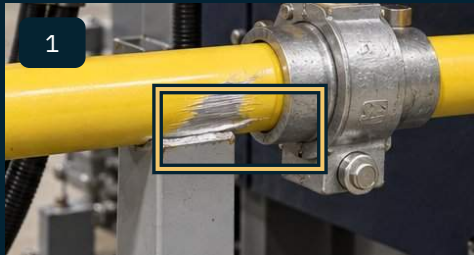
## 1 / Abrasion Patch

Bright wear scar through paint on tube underside

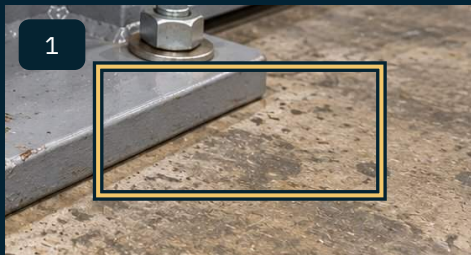
## 1 / Rust-Stained Washer

Corrosion bleed from washer onto base plate
