INSPECTION REPORT • MAINTENANCE PROGRAM

# PACKAGED FIRETUBE BOILER BLR-01

Lakeshore Packaging Co. — Plant 2 • Marion, Ohio

IM-2026-0147

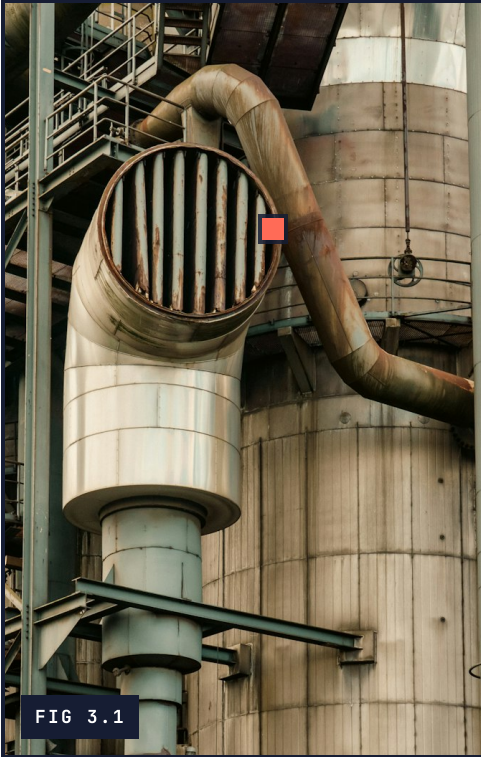
FIG 3.1

## FLUE DUCT — HEAVY CORROSION

DUCT ELBOW

■ HIGH

Machine vision flagged advanced surface corrosion across the flue-duct elbow, heaviest on the outer radius and around the louvered intake rim. Scale and pitting are consistent with long-term condensate exposure. History shows this region was repainted in 2023; the recurrence interval indicates coating alone is no longer sufficient.

*Recurring since the 2023 repaint — check duct wall thickness at the elbow.*

| P1 | <b>Repair flue-duct elbow</b><br>TARGET • WITHIN 72 HOURS – UT THICKNESS SURVEY, PATCH OR REPLACE BELOW-MINIMUM WALL, RE-COAT | HIGH |

Repair within 72 hours: UT thickness survey at the elbow, patch or replace any wall below minimum, then re-coat. Verify low-point drainage to arrest condensate attack.

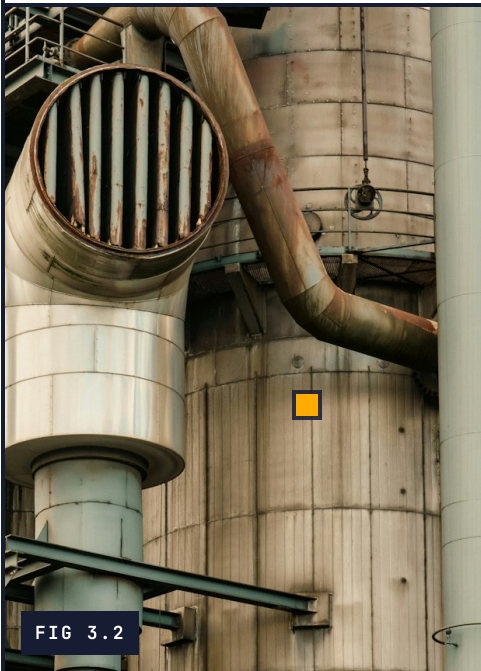
FIG 3.2

## CASING — SURFACE CORROSION

VESSEL SHELL

■ MED

Uniform surface corrosion and staining across the shell casing. Compared against prior inspections, coverage is trending up year over year. No deep pitting or section loss detected; the condition is cosmetic-to-early-stage and coating-driven.

*Staining is heaviest below the upper platform drain — check the gutter discharge before recoating or it will come right back.*

| P2 | <b>Schedule casing recoat</b><br>TARGET • NEXT PLANNED OUTAGE – SPOT-BLAST AND RECOAT VESSEL SHELL | MED |

Schedule spot-blast and recoat at the next planned outage. Monitor quarterly; escalate if pitting develops.

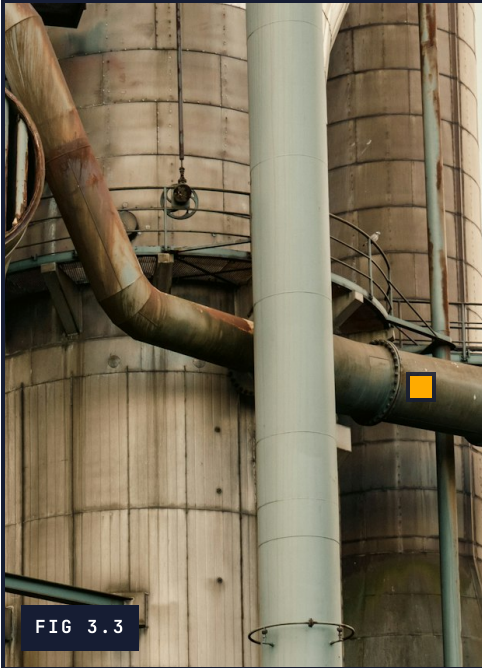
FIG 3.3

## FLANGE WEEP

RISER PIPE

MED

A minor weep at the bolted riser-pipe flange, with wetting and light staining below the joint. Pattern is consistent with gasket relaxation rather than flange-face damage. The system auto-generated a follow-up question; the technician confirmed no active drip at operating pressure.

*Dry to the touch at low fire; weep only shows above ~100 psig.  
Marked the two suspect studs with paint pen for the shutdown crew.*

| P1 | <b>Re-torque riser-pipe flange</b><br>TARGET • NEXT SHUTDOWN – RE-TORQUE TO SPEC, REPLACE GASKET IF WEEP PERSISTS | MED |

Re-torque to specification at the next shutdown; replace the gasket if the weep persists. Recheck in 30 days.

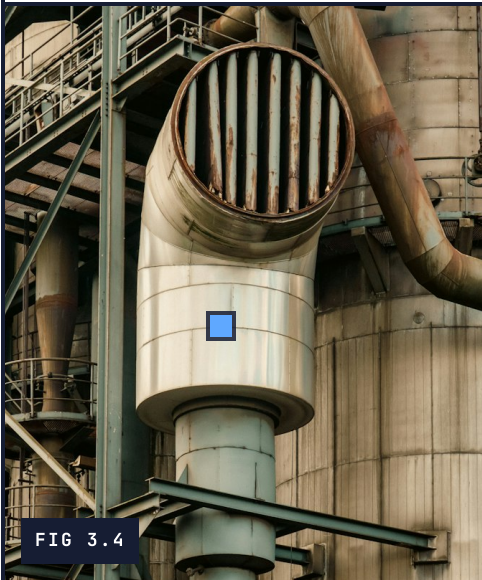
FIG 3.4

## INSULATION JACKET — INTACT

JACKETED COWL

OK

Aluminum jacketing on the transition cowl is sound: joints sealed, no gaps, crush damage or moisture ingress. Surface temperatures nominal for the service.

*Jacket was re-banded during the 2024 outage — holding up well.*

| P3 | <b>Recheck insulation at next PM</b><br>TARGET • ROUTINE – NO ACTION REQUIRED NOW | OK |

No action required. Recheck at the next preventive-maintenance interval.
