# ATLAS T-240

Wear and deterioration inspection

DEMO-001

10 Feb 2026

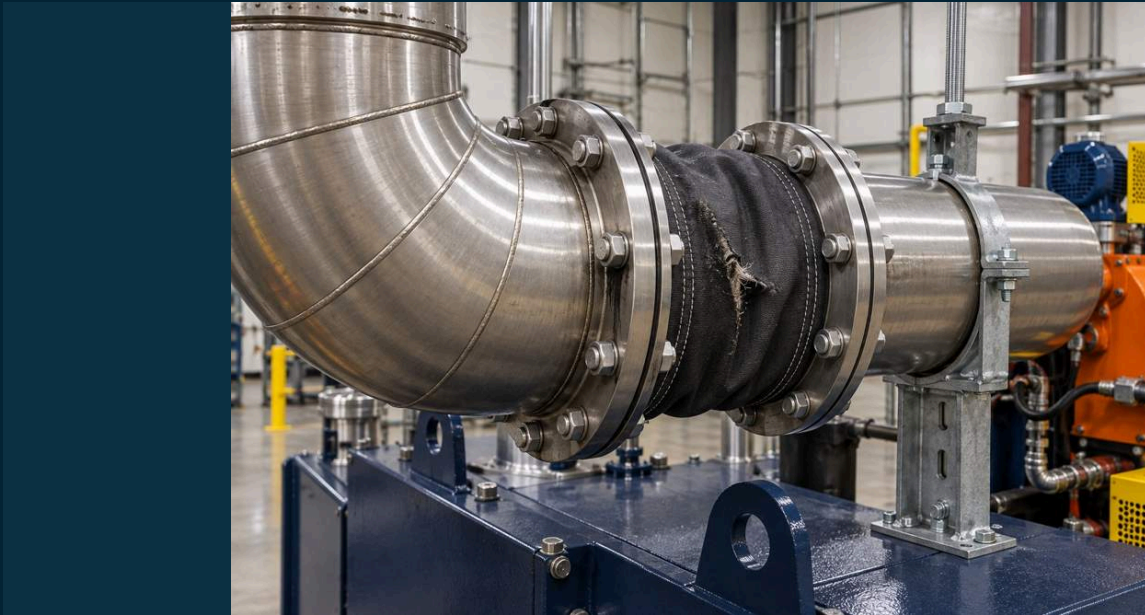
EVIDENCE 01 / Synthetic inspection photo · DUC-01

I photographed ductwork and flexible connector. The flexible connector has a split outer fold with loose fibers and a dark streak below the clamp edge. I did not perform a leak test or inspect the concealed inner fabric.

Flexible fabric connector between two flanged duct sections shows a torn outer fold with protruding fibers and a dark streak along the lower flange, consistent with the technician's observation of a split and possible leakage indication.

Schedule replacement of the flexible connector and perform a leak test; inspect concealed inner fabric before return to service.

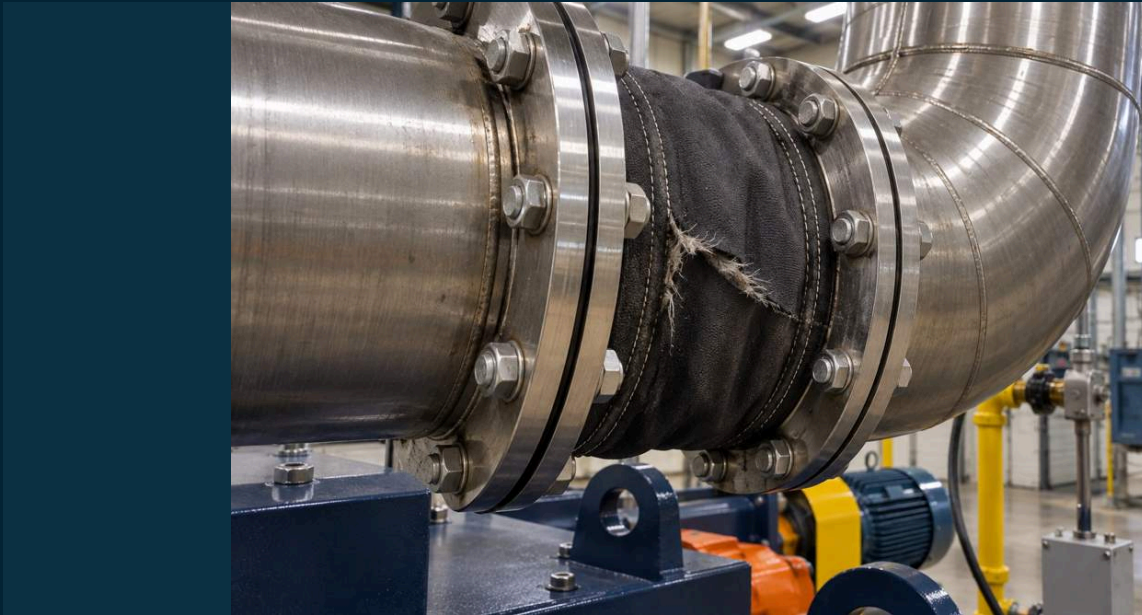
EVIDENCE 01 / Synthetic inspection photo · DUC-02

I checked the accessible surfaces closely. The flexible connector has a split outer fold with loose fibers and a dark streak below the clamp edge. I did not perform a leak test or inspect the concealed inner fabric.

Flexible connector fabric between the two flanged duct sections shows a visible split in the outer fold with protruding loose fibers and a dark streak below the clamp, consistent with the technician's observation of active degradation.

Dark streak/discoloration on the fabric below the clamp edge, suggestive of leakage or soot tracking along the tear. [MEDIUM]

Inner fabric layer and concealed circumference not visible in this view; full extent of damage cannot be confirmed. [LOW]

Schedule flexible connector replacement; perform leak check and inspect concealed circumference before continued service.

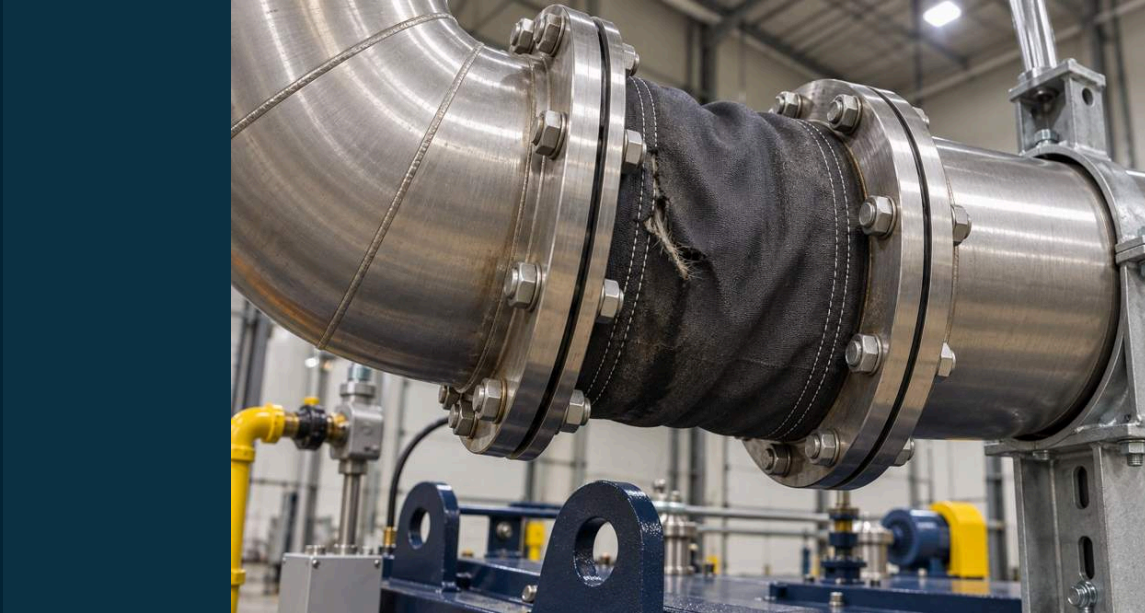
EVIDENCE 01 / Synthetic inspection photo · DUC-03

I took this additional view to document the condition for follow-up. The flexible connector has a split outer fold with loose fibers and a dark streak below the clamp edge. I did not perform a leak test or inspect the concealed inner fabric.

Fabric flexible connector between two flanged spools shows a visible split in the outer fold with protruding loose fibers and a dark streak below the clamp edge; internal fabric condition and leak-tightness remain unverified.

Outer fold of the flexible connector fabric is split, exposing loose fibers consistent with mechanical tearing or fatigue. [HIGH]

Dark streak on the fabric below the clamp/flange edge is present, potentially indicating seepage, staining, or accumulated debris; source not confirmed. [MEDIUM]

Concealed inner fabric layer and leak-tightness not verified in this inspection. [LOW]

Take connector out of service for internal inspection and leak test; plan replacement of flexible element.

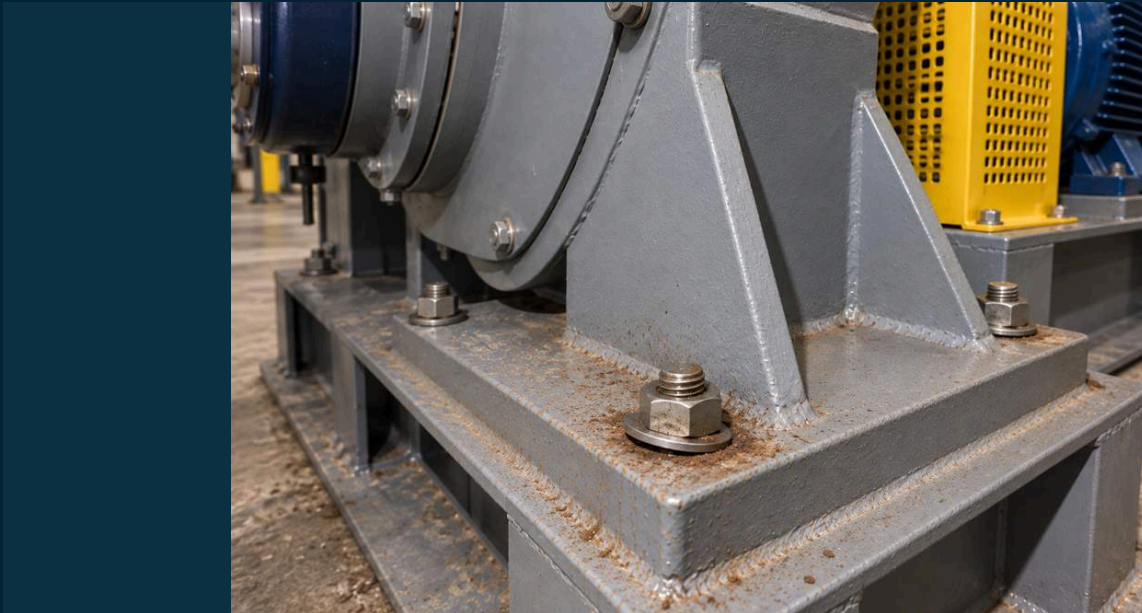
EVIDENCE 01 / Synthetic inspection photo · FAN-MNT-02

I checked the accessible surfaces closely. The front washer appears lifted at one edge, with rust-colored fretting debris spread across the pedestal foot. I recorded 6.2 mm/s RMS at the same pedestal point in mode M1, compared with 3.1 mm/s RMS on the prior visit. I did not open the bearing housing; internal bearing condition remains unverified.

Front hold-down washer shows edge lift with rust-colored fretting debris across the pedestal foot, corroborated by a doubling of vibration (3.1→6.2 mm/s RMS) at this pedestal in mode M1, indicating an active loosening/fretting condition at the anchor.

Re-torque front hold-down to spec, inspect washer/bolt for fretting wear, clean and monitor debris regeneration, and re-measure vibration; schedule bearing check if levels remain elevated.
