INSPECTION REPORT • MAINTENANCE PROGRAM

# PACKAGED FIRETUBE BOILER BLR-01

Lakeshore Packaging Co. — Plant 2 • Marion, Ohio

IM-2026-0147

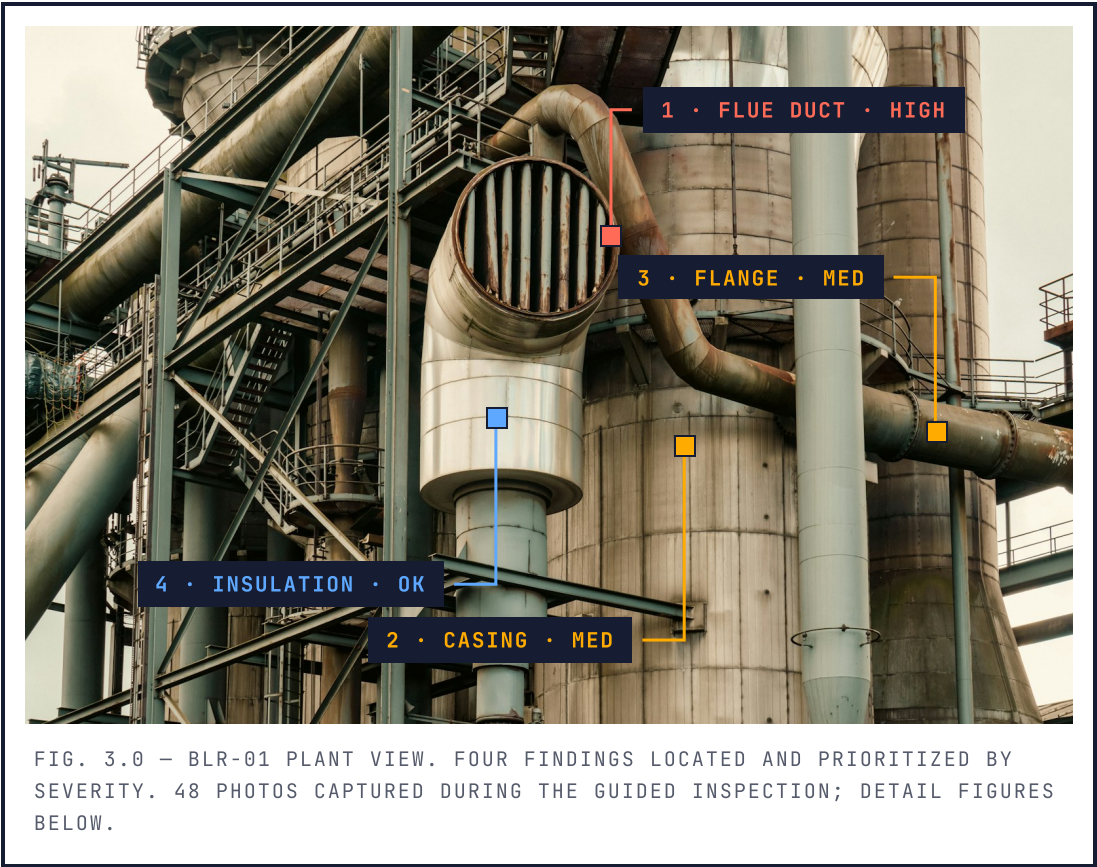
1

## FLUE DUCT — HEAVY CORROSION

DUCT ELBOW

■ HIGH

Machine vision flagged advanced surface corrosion across the flue-duct elbow, heaviest on the outer radius and around the louvered intake rim. Scale and pitting are consistent with long-term condensate exposure. History shows this region was repainted in 2023; the recurrence interval indicates coating alone is no longer sufficient.

*Recurring since the 2023 repaint — check duct wall thickness at the elbow.*

| P1 | <b>Repair flue-duct elbow</b><br>TARGET • WITHIN 72 HOURS – UT THICKNESS SURVEY, PATCH OR REPLACE BELOW-MINIMUM WALL, RE-COAT | HIGH |

Repair within 72 hours: UT thickness survey at the elbow, patch or replace any wall below minimum, then re-coat. Verify low-point drainage to arrest condensate attack.
