# ATLAS T-240

Wear and deterioration inspection

DEMO-001

10 Feb 2026

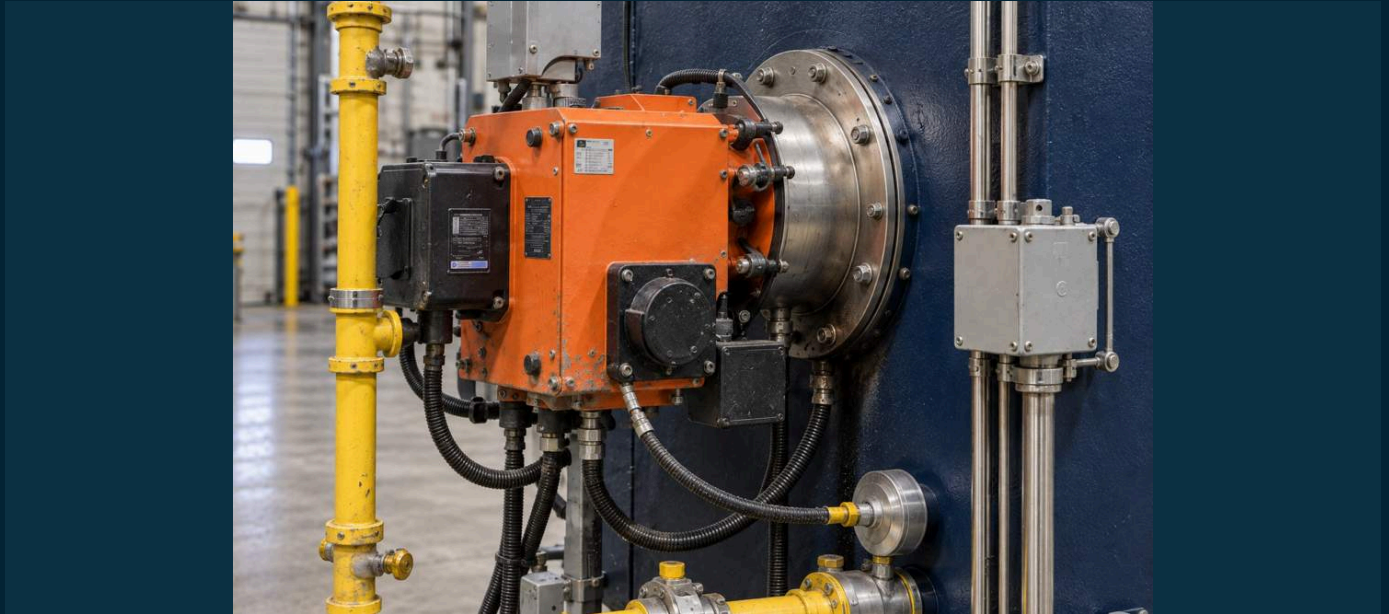
EVIDENCE 01 / Synthetic inspection photo · BRN-01

I photographed burner assembly. The lower orange casing is chipped and dusty. I can see a dark streak beneath the mounting flange. I did not open the burner or establish combustion quality from the exterior photograph.

Burner assembly is visible and mounted to the vessel flange; exterior shows chipped/dusty orange casing paint and a dark streak beneath the mounting flange, warranting follow-up but no confirmed active failure from the photo.

Burner assembly and surrounding flange, conduit, and gas piping context are clearly captured, satisfying the overview checklist item. [NONE]

Lower portion of the orange burner casing shows paint chipping, scuffing, and dust accumulation consistent with technician's observation. [LOW]

Dark streak/staining visible on the vessel wall beneath the mounting flange may indicate prior seepage or run-down of contamination. [MEDIUM]

Combustion quality and internal condition cannot be assessed from exterior photograph. [NONE]

Wipe down casing, investigate origin of dark streak beneath flange, and schedule internal burner inspection.

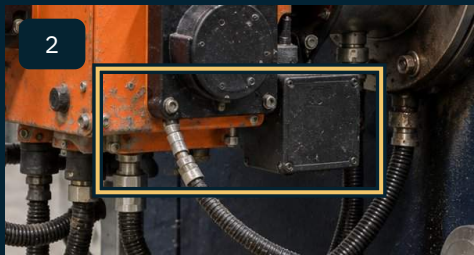
WARNING

Dark run-down staining beneath mounting flange

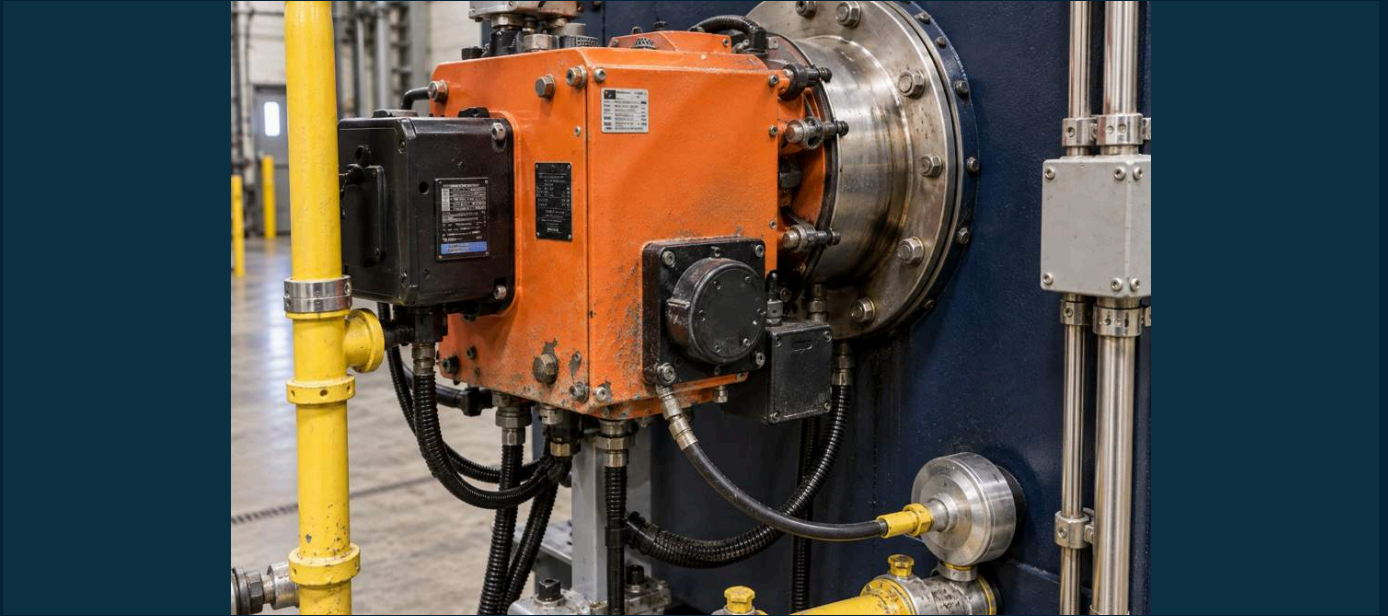
EVIDENCE 01 / Synthetic inspection photo · BRN-02

I checked the accessible surfaces closely. The lower orange casing is chipped and dusty. I can see a dark streak beneath the mounting flange. I recorded the flame-signal display at 2.9 microamps in mode M1, below the 3.8 microamps recorded on the prior visit. I did not open the burner or establish combustion quality from the exterior photograph.

Burner assembly exterior shows chipped/dusty orange casing and a dark streak beneath the mounting flange; technician-reported flame signal has dropped from 3.8  $\mu\text{A}$  to 2.9  $\mu\text{A}$ , indicating degradation warranting investigation.

Lower orange burner casing shows chipped paint and surface dust accumulation as reported by technician. [LOW]

Dark streak visible beneath the mounting flange consistent with technician observation, possibly moisture or fluid tracking. [MEDIUM]

Flame signal recorded at 2.9  $\mu\text{A}$  in mode M1, down from 3.8  $\mu\text{A}$  on prior visit - external condition alone cannot confirm cause. [MEDIUM]

Investigate flame-signal drop: clean/inspect flame scanner and lens, trace source of dark streak beneath flange, and schedule burner-side inspection.

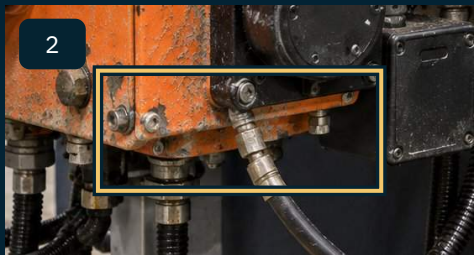
**WARNING**

Dark tracking beneath mounting flange, possible moisture path

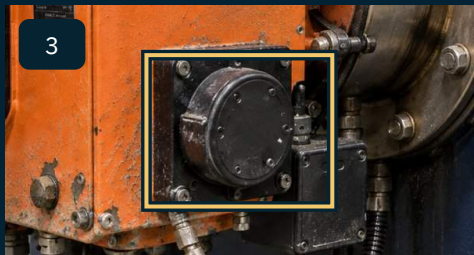
## 2 / Chipped Casing Paint

**WARNING**

Paint chipping and dust on lower orange casing

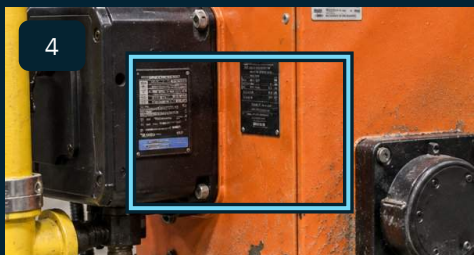
## 3 / Flame Scanner Housing

**WARNING**

Scanner head associated with degraded flame signal reading

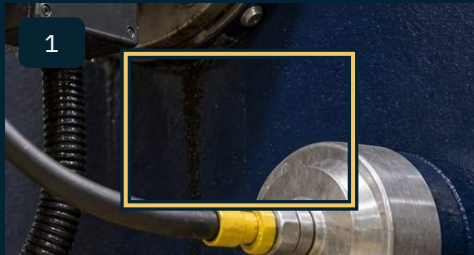
## 1 / Dark Streak Below Flange

**WARNING**

Vertical dark track beneath mounting flange, unknown source

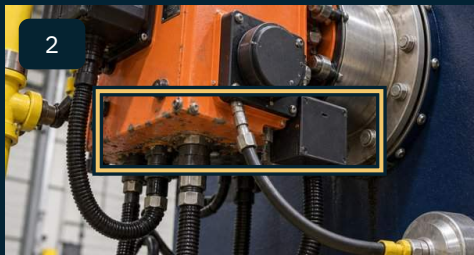
## 2 / Chipped Casing Paint

**WARNING**

Lower orange casing chipped and dust-soiled

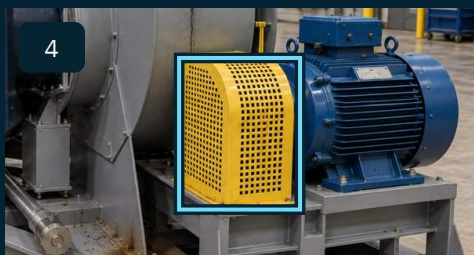
## 3 / Bearing Pedestal

INFO

Bearing housing closed; internal condition unverified

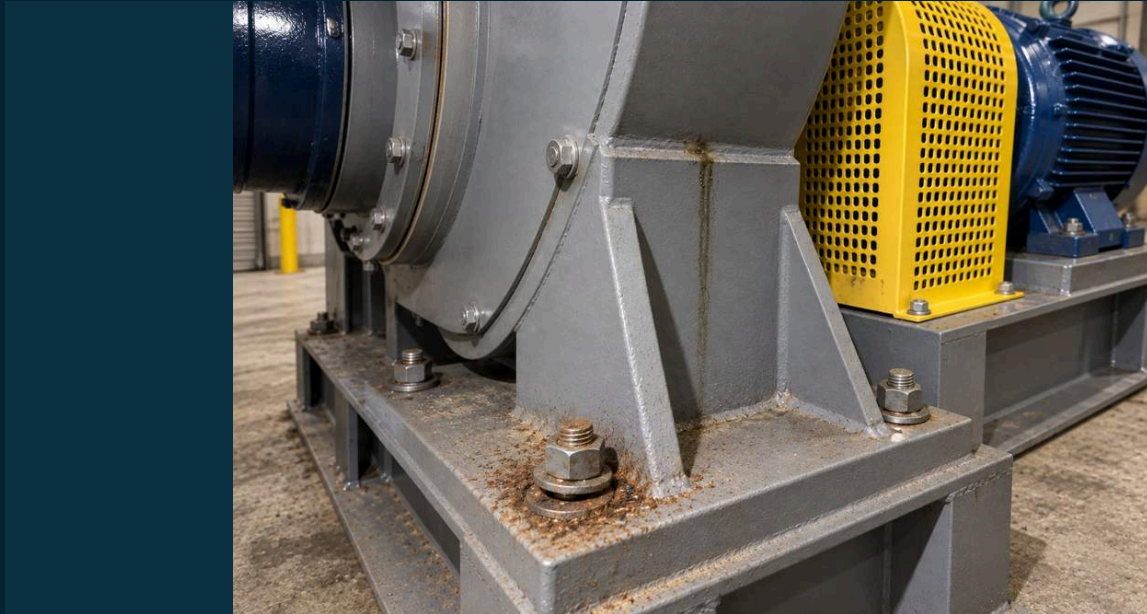
EVIDENCE 01 / Synthetic inspection photo · FAN-02

Front pedestal hold-down shows a broad rust-colored fretting debris ring and a dark streak descending the fan housing, coincident with a doubling of vibration (3.1→6.2 mm/s RMS) at the same point. Guard is intact, but the fretting signature plus vibration trend indicates progressive loosening or bearing/imbalance degradation requiring intervention.

Retorque hold-down bolts to spec, inspect washers for lift/fretting, sample the streak for grease vs. process fluid, and schedule bearing vibration spectrum analysis before continued operation.

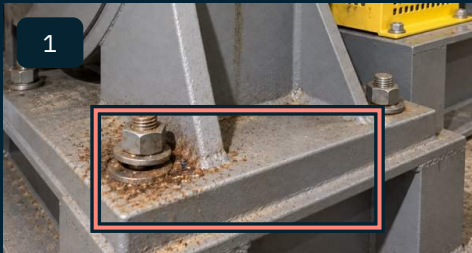
## 1 / Fretting Debris Ring

CRITICAL

Rust-colored fretting halo around pedestal hold-down

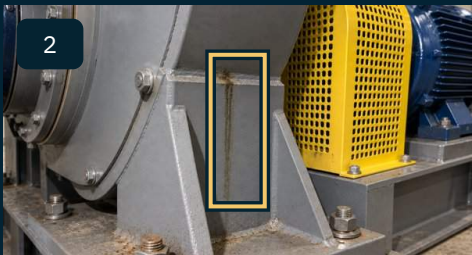
## 2 / Housing Streak

WARNING

Dark vertical streak down fan housing centerline

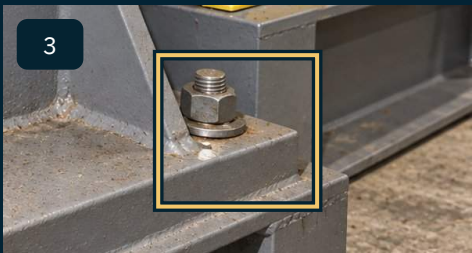
## 3 / Secondary Hold-Down

WARNING

Check washer seating and fretting at rear anchor

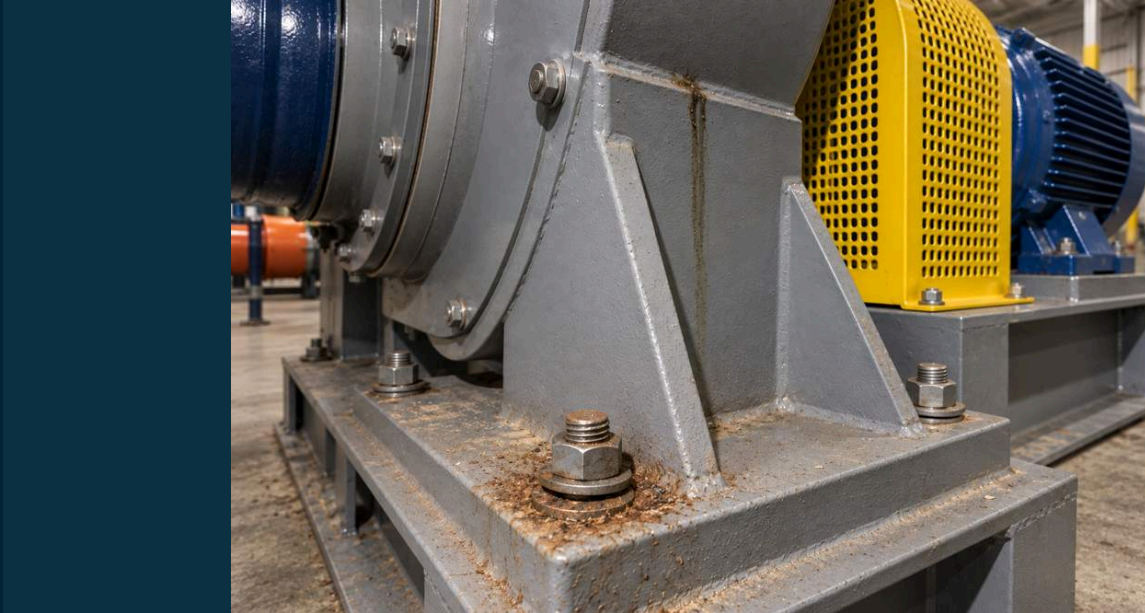
EVIDENCE 01 / Synthetic inspection photo · FAN-03

Front pedestal shows a broad rust-colored debris ring around the hold-down bolt and a dark vertical streak down the housing web; measured vibration at this point has doubled to 6.2 mm/s RMS in mode M1. Internal bearing condition is not verified from this external view.

Schedule bearing inspection and root-cause review of debris/streak; trend vibration and plan intrusive check before next run cycle.

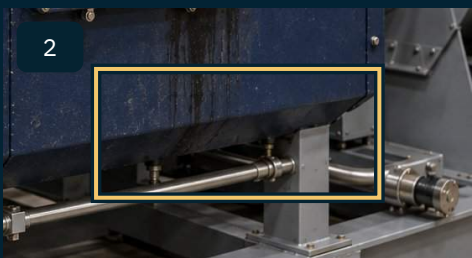
**WARNING**

Dark streak emerging from lower right hatch edge

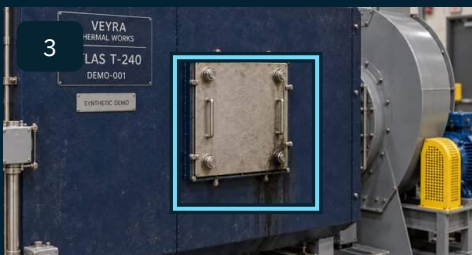
## 2 / Staining On Chamber Wall

**WARNING**

Deposit spreading downward across navy panel

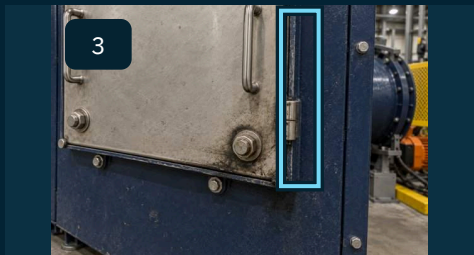
WARNING

Soot deposit along hatch seal interface

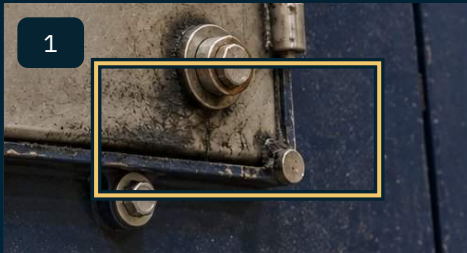
## 1 / Black Leak Track

**WARNING**

Dark deposit spreading from lower right hatch edge

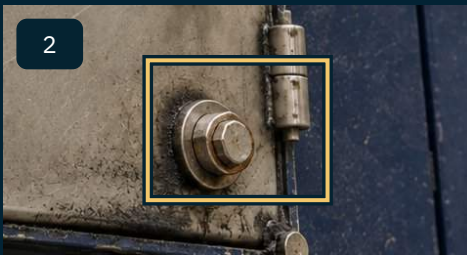
## 2 / Latch Bolt Area

**WARNING**

Sooting concentrated around lower latch bolt

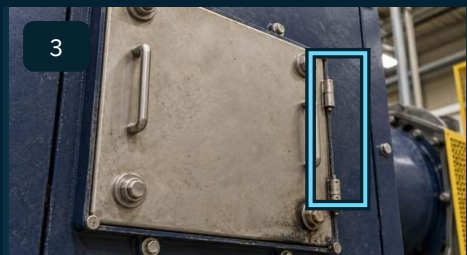
## 3 / Hinge Assembly

**INFO**

Hinges intact, no visible misalignment

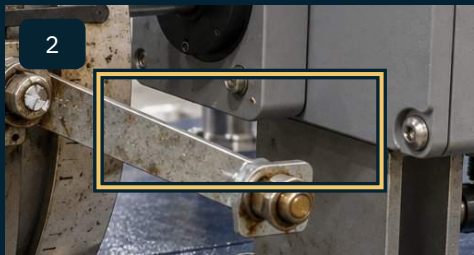
WARNING

Brown residue at linkage pivot bolt

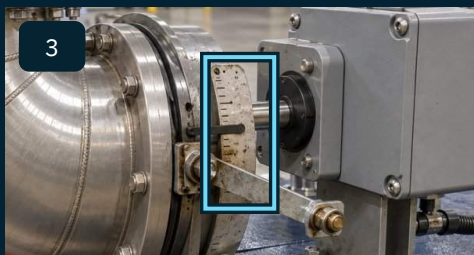
## 3 / Soiled Position Scale

Scale plate dirty, graduations partially obscured

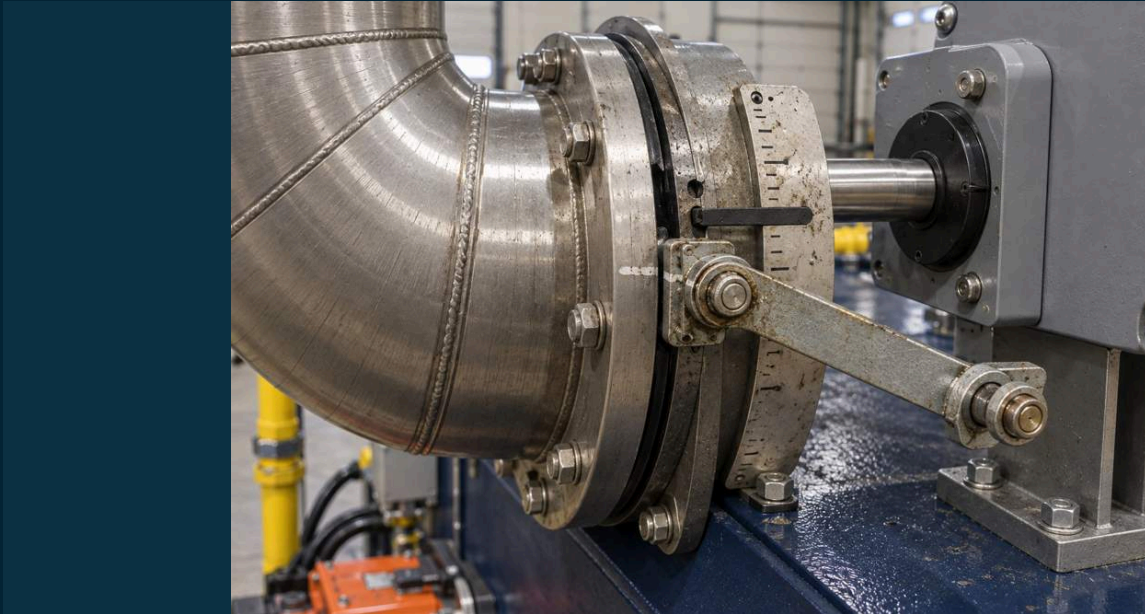
EVIDENCE 01 / Synthetic inspection photo · DMP-02

I checked the accessible surfaces closely. There is brown residue at the linkage pivot and the witness paint is broken across the joint. The position scale is dirty. In mode M1 I recorded a 50% command and approximately 43% indicated position; I have requested a travel and linkage check. The still photo does not establish full travel or calibration.

Damper linkage shows brown residue at the pivot and broken witness paint across the joint, with a soiled position scale; technician also reports a command-vs-indicated position mismatch (50% cmd / ~43% ind) requiring a travel and linkage check.

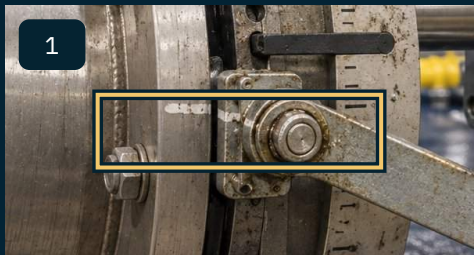
## 1 / Broken Witness Paint

White witness stripe offset across pivot joint

Witness paint stripe across the pivot joint is broken, indicating relative movement of the fastened joint since marking. [MEDIUM]

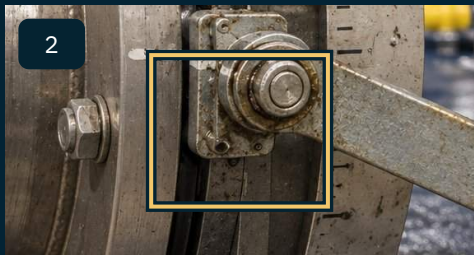
## 2 / Pivot Residue

Brown residue around linkage pivot fastener

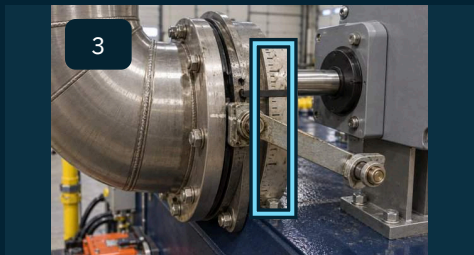
## 3 / Soiled Position Scale

Graduated scale contaminated, readout obscured

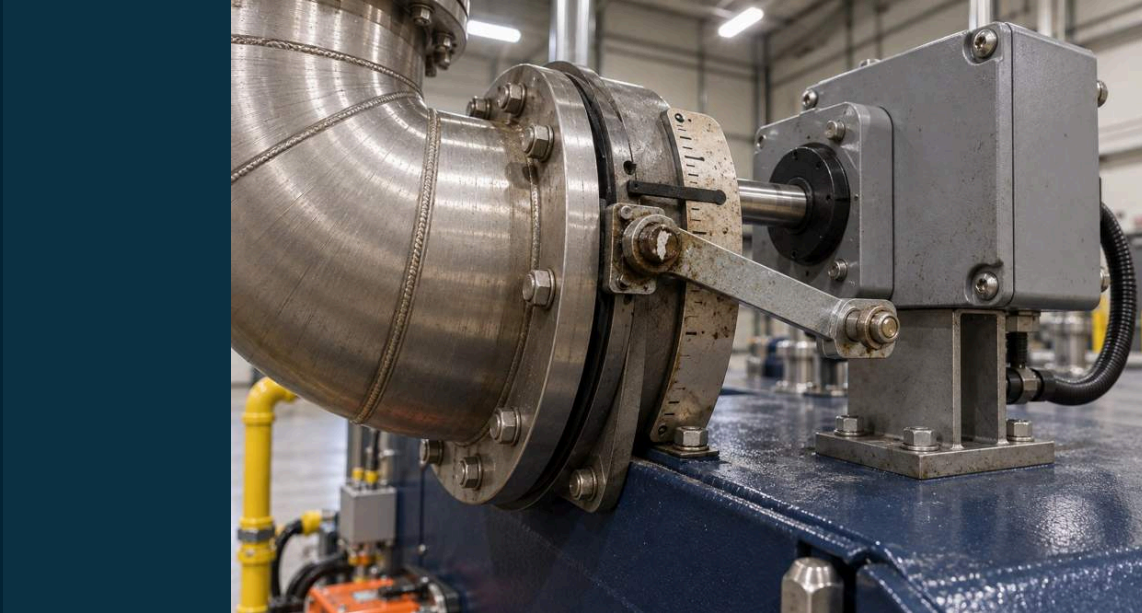
EVIDENCE 01 / Synthetic inspection photo · DMP-03

I took this additional view to document the condition for follow-up. There is brown residue at the linkage pivot and the witness paint is broken across the joint. The position scale is dirty. In mode M1 I recorded a 50% command and approximately 43% indicated position; I have requested a travel and linkage check. The still photo does not establish full travel or calibration.

Airflow damper linkage shows brown residue at the pivot, broken witness paint across the joint, and a soiled position scale; technician reports a 7% deviation between commanded and indicated position in M1, and full travel/calibration is not established by this still image.

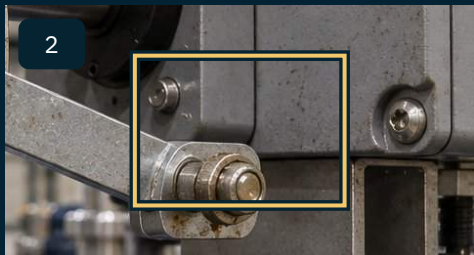
## 2 / Pivot Residue

Brown residue accumulated around pivot bolt

Brown residue visible at the linkage pivot bolt, consistent with weep or corrosion product at the joint. [MEDIUM]

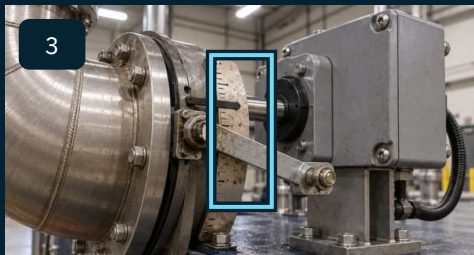
## 3 / Soiled Position Scale

Scale markings obscured by dirt film

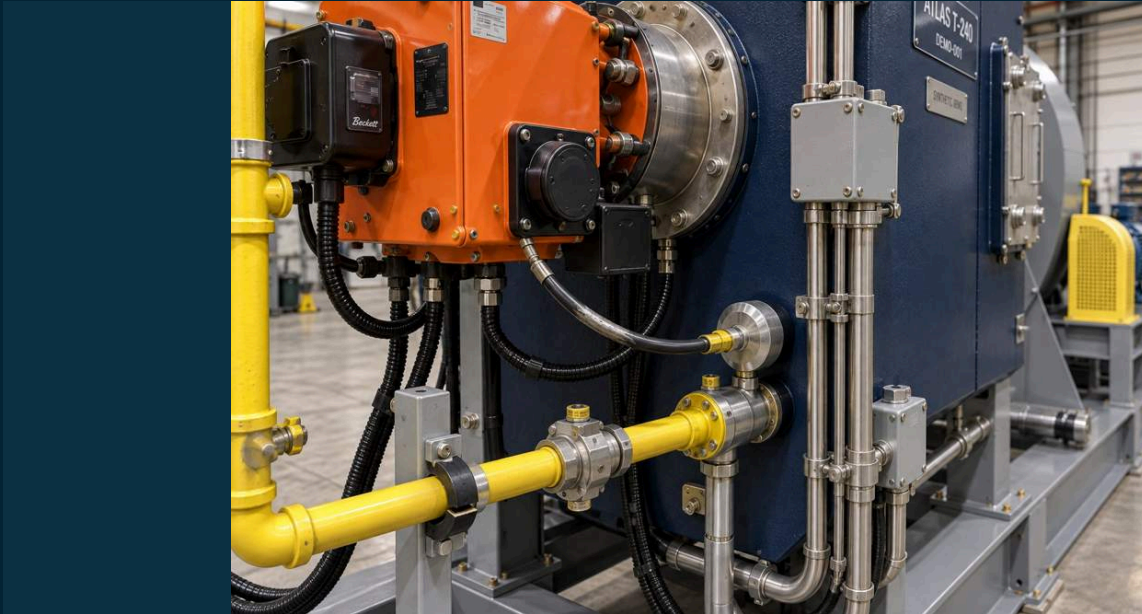
EVIDENCE 01 / Synthetic inspection photo · SNS-01

Sensor and impulse tubing assembly shows abrasion wear where yellow tubing contacts a support bracket, with a split and displaced clamp liner at the lower bracket per technician observation.

Replace split clamp liner, inspect abraded tubing wall thickness, and re-secure with proper cushioning to prevent further wear.

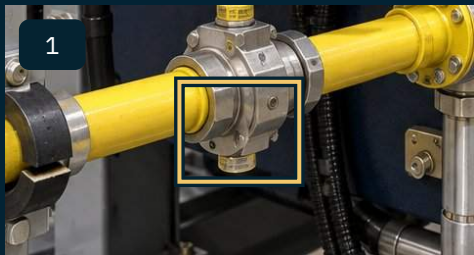
## 1 / Split Clamp Liner

Lower clamp liner split and displaced from bracket

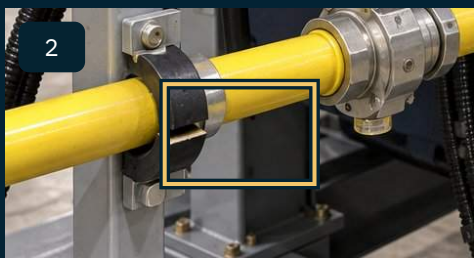
## 2 / Tubing Abrasion Patch

Bright wear scar where tubing contacts bracket

Bright abrasion patch visible on yellow tubing at bracket contact point, indicating ongoing mechanical wear. [MEDIUM]

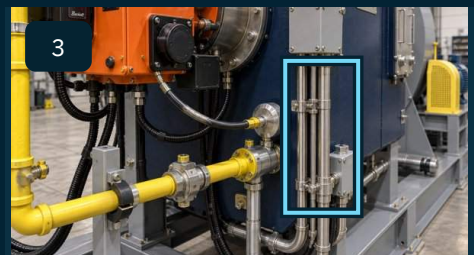
## 3 / Impulse Tubing Runs

Stainless impulse lines routed and supported

Stainless impulse tubing runs and sensor manifolds appear intact and correctly routed against the vessel wall. [NONE]

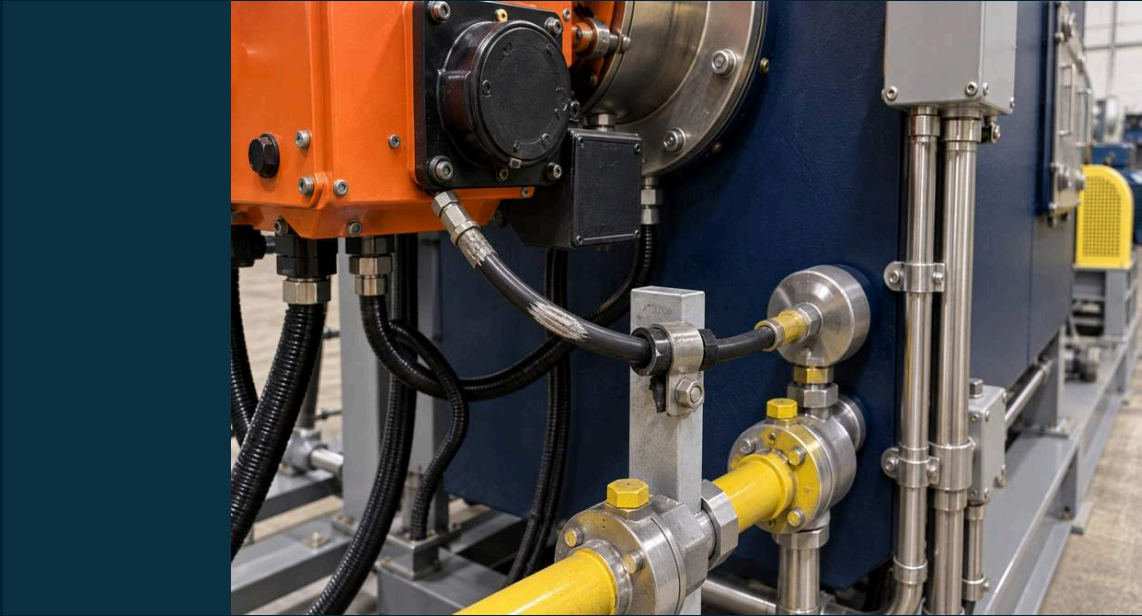
EVIDENCE 01 / Synthetic inspection photo · SNS-02

Sensor impulse tubing shows a bright abrasion patch where it contacts the support bracket, and the lower clamp liner is split and displaced. Visual condition only; no calibration assessment performed.

Replace split clamp liner and inspect abraded tubing section; re-support to eliminate contact wear.

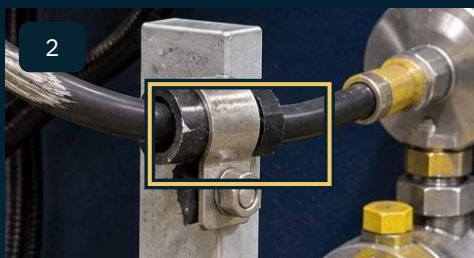
## 2 / Split Clamp Liner

Lower liner split and displaced from seat

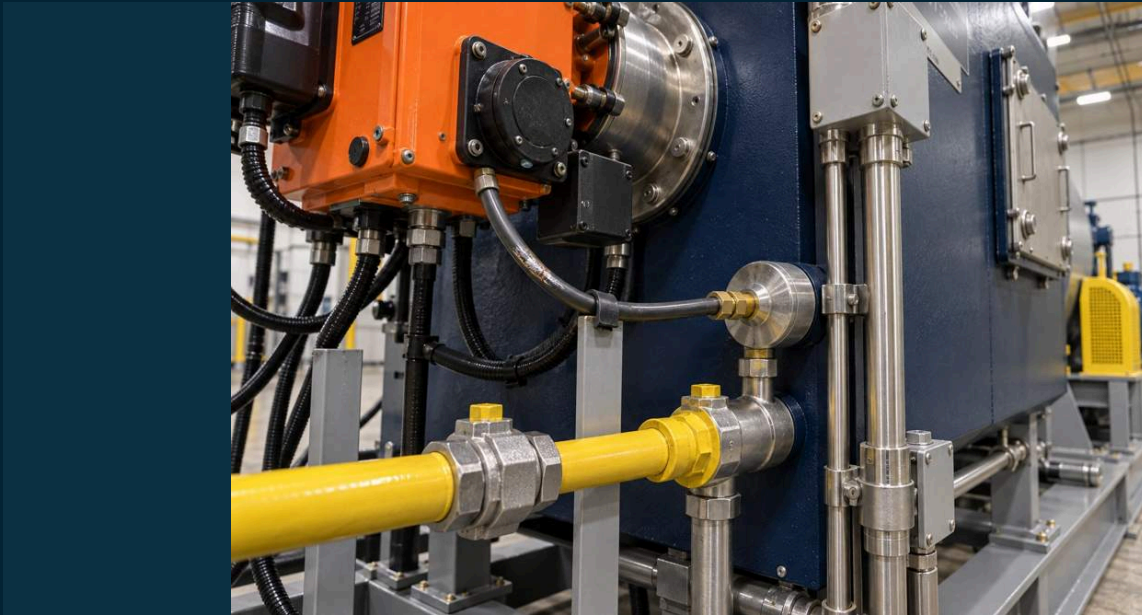
EVIDENCE 01 / Synthetic inspection photo · SNS-03

I took this additional view to document the condition for follow-up. The tubing has a bright abrasion patch where it touches the bracket. The lower clamp liner is split and displaced. I did not perform calibration or pressure testing.

Replace split clamp liner, re-support tubing to eliminate bracket contact, inspect abraded section for wall thinning, and schedule pressure/calibration check.

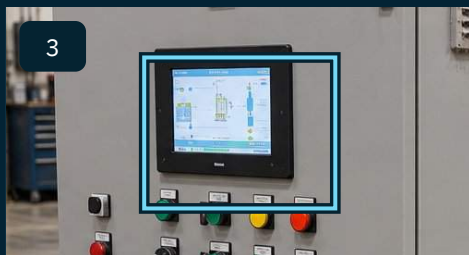
## 3 / HMI Display Active

Operator screen powered and rendering process graphic

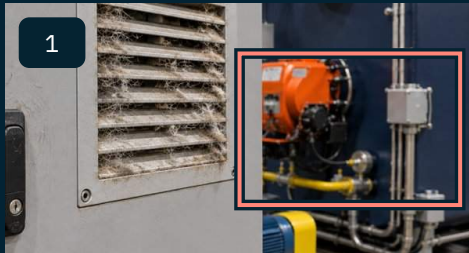
## 1 / Lint-Blocked Louvers

Fibrous debris bridging slats, blocking intake airflow

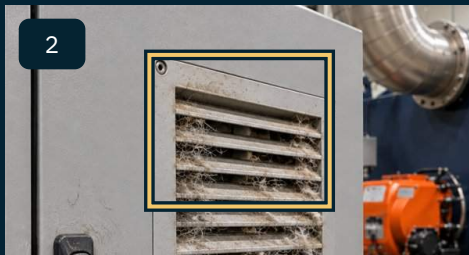
## 2 / Dust-Loaded Grille

Heavy dust accumulation across upper intake face

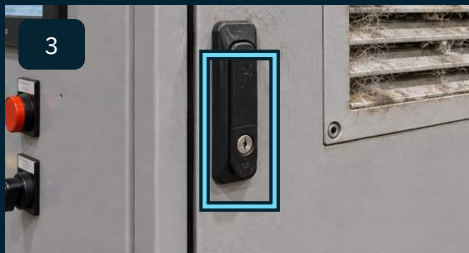
## 3 / Scuffed Handle Area

Smudging and wear around door latch

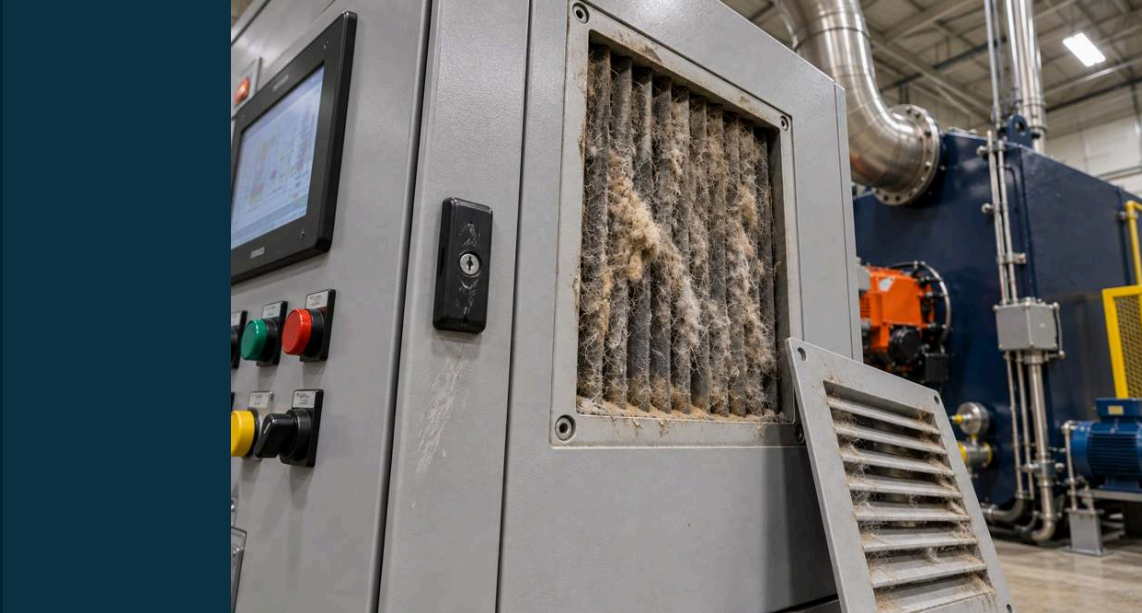
EVIDENCE 01 / Synthetic inspection photo · CTL-03

I took this additional view to document the condition for follow-up. Dust and lint have built up across the intake grille. The cabinet door is closed and the handle area is scuffed. I recorded enclosure temperature at 48 C in mode M1 and a cabinet-temperature warning in the alarm history. I did not open or inspect the electrical compartment.

Replace/clean intake filter and louver, then re-run mode M1 and monitor enclosure temperature; schedule internal cabinet inspection.

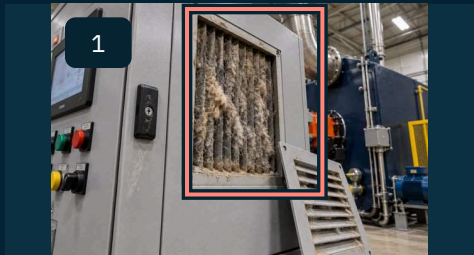
## 1 / Fouled Intake Filter

Heavy lint mat blocking cooling airflow

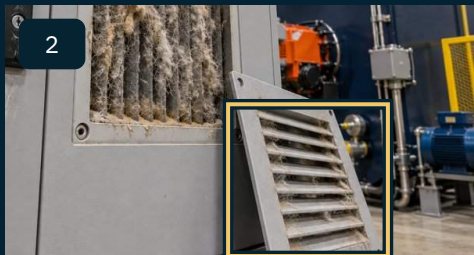
## 2 / Louver Cover Loaded

Removed grille cover coated with lint

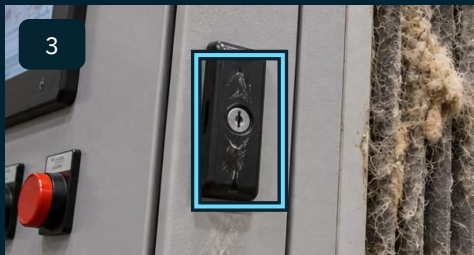
## 3 / Scuffed Lock Area

Handle/keyway shows wear, door still closed

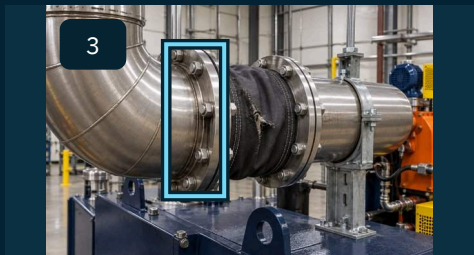
## 3 / Upstream Flange

Bolted flange intact, alignment appears normal.

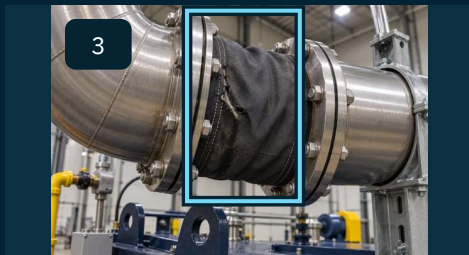
## 3 / Upstream Flange

Bolted flange intact, no visible gap

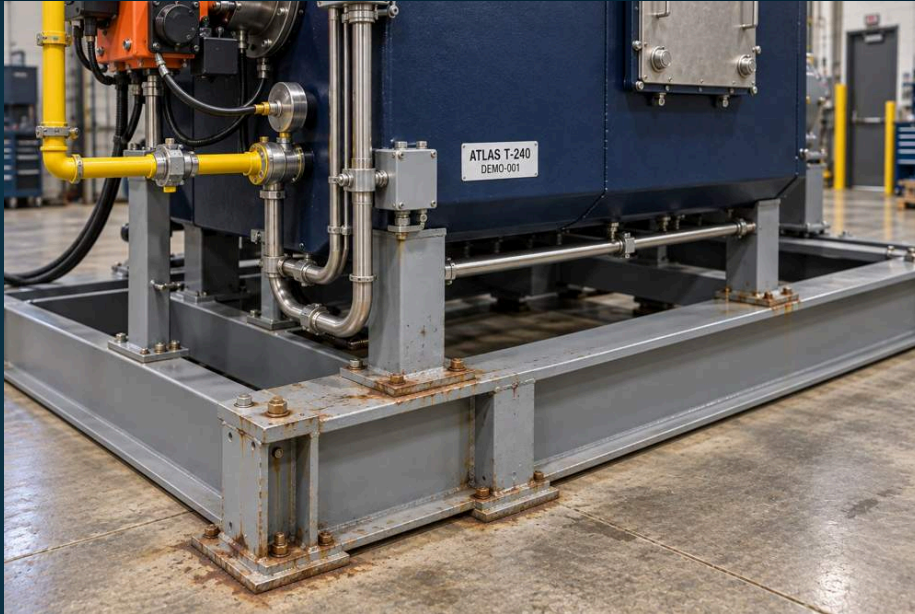
EVIDENCE 01 / Synthetic inspection photo · FRM-01

I photographed skid and identification. There is flaking paint and rust staining around the front support plate and anchor washers. The asset label remains readable. I did not proof-test the anchors or establish their load capacity.

ATLAS T-240 (DEMO-001) skid overview shows readable asset label, but the front support plate and anchor washers exhibit flaking paint and rust staining. Anchor load capacity was not verified.

Flaking paint and rust staining visible on the front support plate/gusset near the base. [LOW]

Rust staining around anchor washers and bolt heads at the front support feet. [LOW]

Clean and touch up corroded areas on front support plate; schedule anchor proof-test to confirm hold-down capacity.

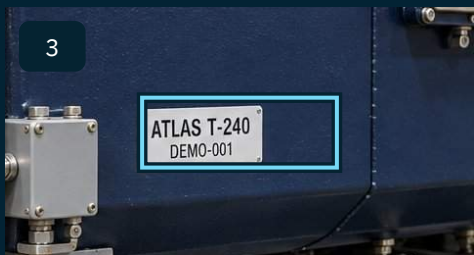
## 3 / Asset Label

ATLAS T-240 DEMO-001 nameplate legible

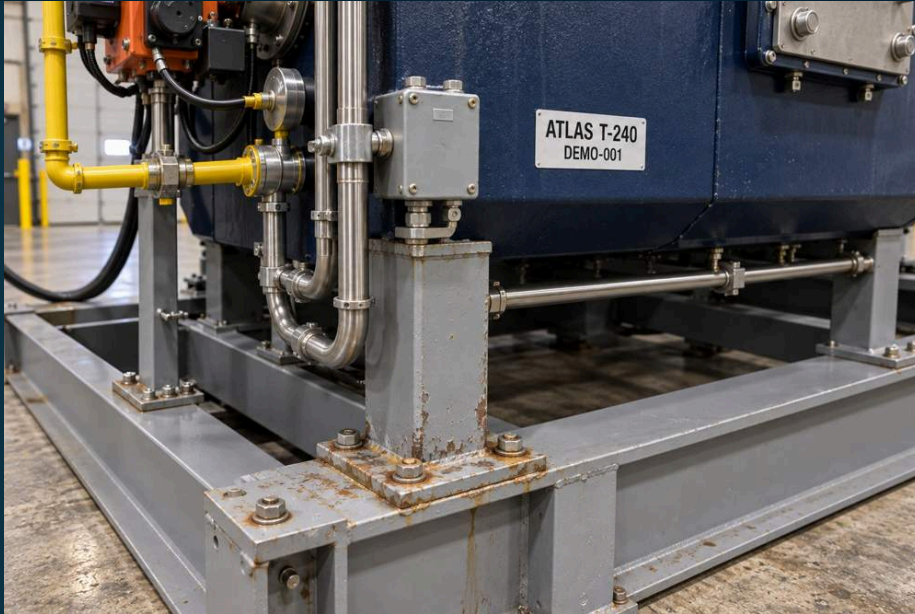
EVIDENCE 01 / Synthetic inspection photo · FRM-02

I checked the accessible surfaces closely. There is flaking paint and rust staining around the front support plate and anchor washers. The asset label remains readable. I did not proof-test the anchors or establish their load capacity.

Front support plate and anchor washers on the ATLAS T-240 skid show flaking paint and rust staining, though the asset label remains legible. Structural integrity of anchors is not confirmed.

Flaking paint and rust staining visible around the front support plate base and anchor washers. [LOW]

Rust streaking extends down the vertical support column from the anchor area. [LOW]

Anchor bolt load capacity not verified; corrosion extent beneath washers unknown. [LOW]

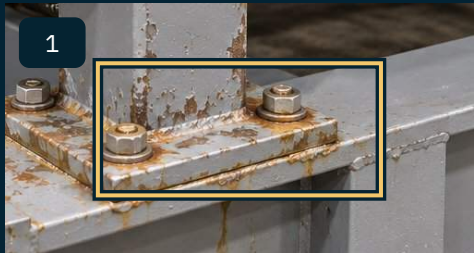
## 1 / Anchor Washer Corrosion

Rust staining around anchor bolts and washers

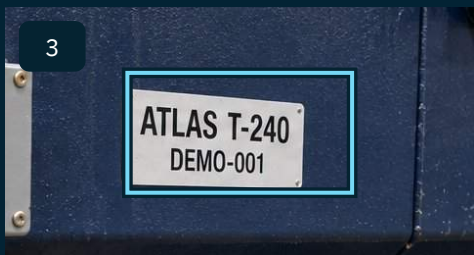
## 3 / Asset Label Legible

ATLAS T-240 DEMO-001 identification clearly readable

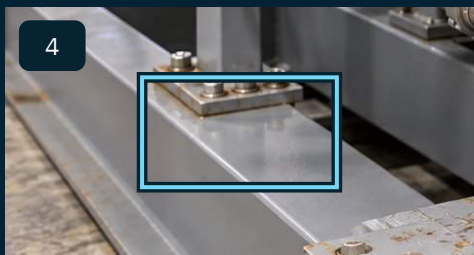
## 4 / Secondary Anchor Point

Adjacent anchor showing minor early staining

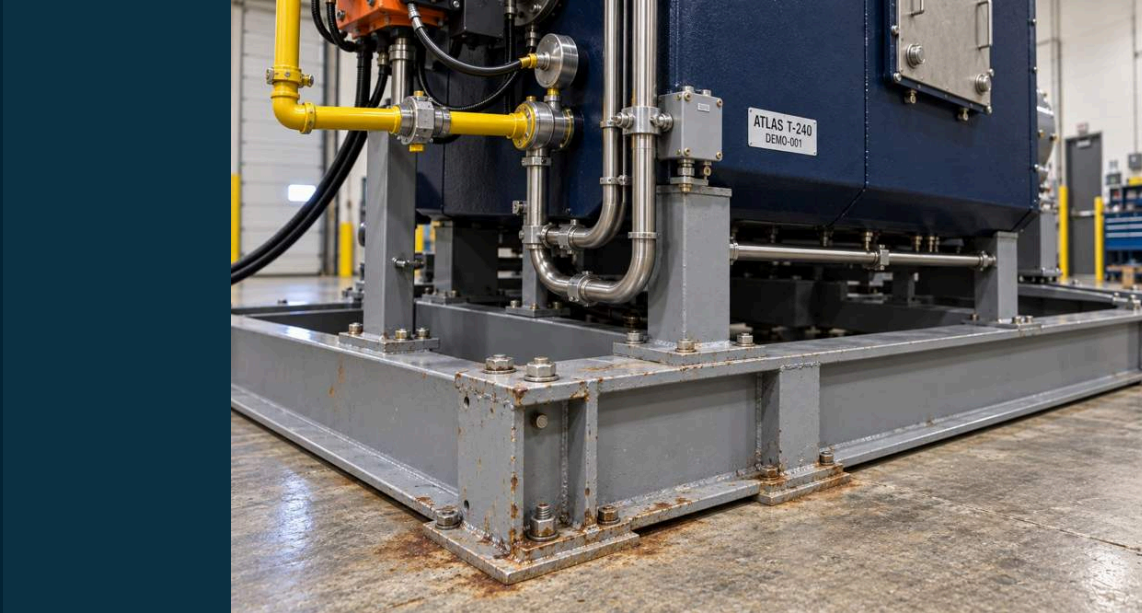
EVIDENCE 01 / Synthetic inspection photo · FRM-03

I took this additional view to document the condition for follow-up. There is flaking paint and rust staining around the front support plate and anchor washers. The asset label remains readable. I did not proof-test the anchors or establish their load capacity.

Front skid support plates and anchor washers show flaking paint and rust staining; asset label (ATLAS T-240, DEMO-001) is legible. Anchor load capacity remains unverified.

Rust staining and paint flaking visible around front support plates and anchor washers. [LOW]

Schedule anchor proof-test and load verification; clean and touch up corroded areas on support plates.

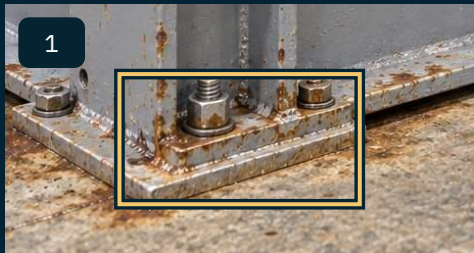
## 1 / Corroded Anchor Washer

Rust staining and paint loss at anchor washer

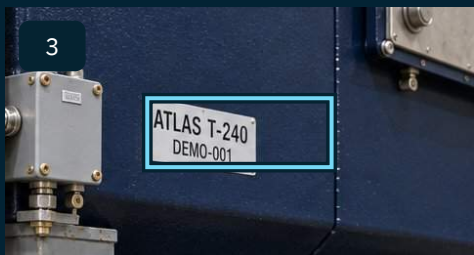
## 3 / Asset Label Legible

ATLAS T-240 DEMO-001 nameplate readable

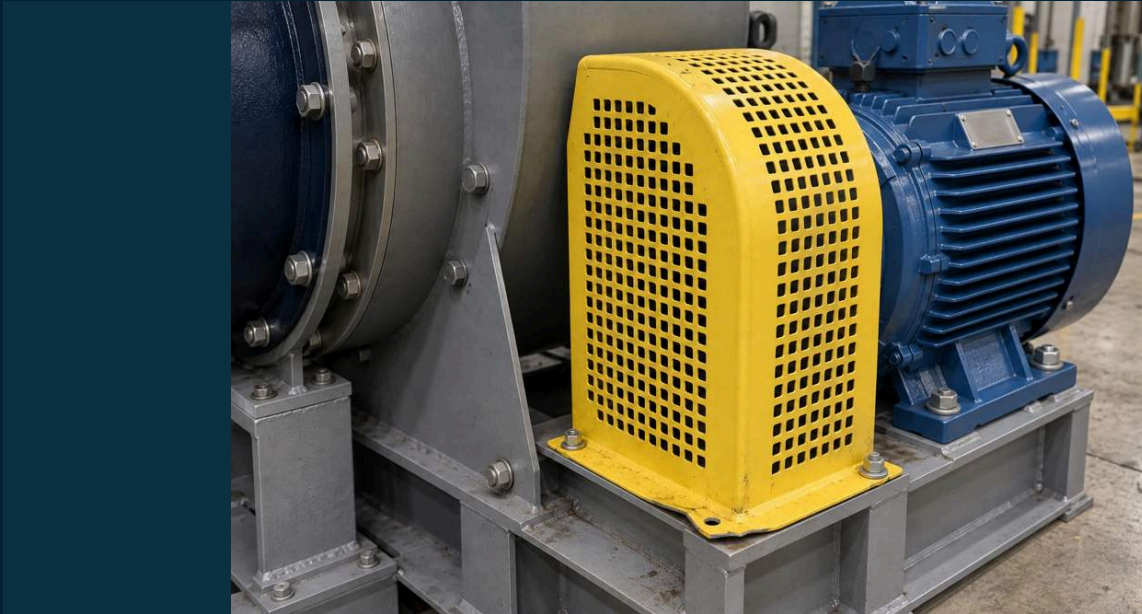
EVIDENCE 01 / Synthetic inspection photo · FAN-GRD-01

I photographed coupling guard. The front lower guard fixing is missing and the edge is slightly bent. The guard is still installed; I have not removed it. I did not open the bearing housing; internal bearing condition remains unverified.

Yellow coupling guard between motor and fan is in place but the front lower baseplate shows a missing fixing and a slightly deformed edge, consistent with the technician's observation.

Front lower guard baseplate is missing a fixing bolt at the near corner. [LOW]

Mesh panels intact; no exposed gaps to rotating coupling observed. [NONE]

Reinstall missing fixing bolt and straighten or replace bent baseplate edge; re-torque remaining fixings.

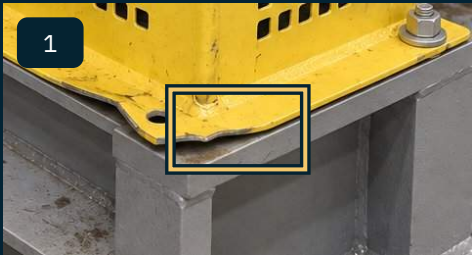
## 1 / Missing Fixing

WARNING

Front lower guard fixing absent at corner

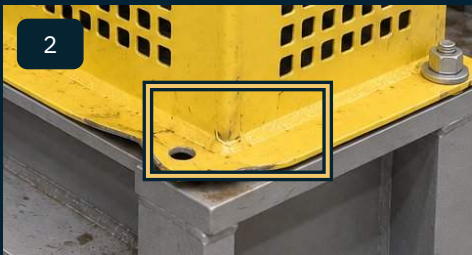
## 2 / Bent Edge

WARNING

Guard baseplate edge slightly deformed

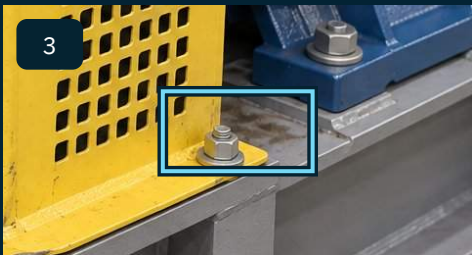
## 3 / Secured Fixing

Opposite baseplate bolt properly torqued

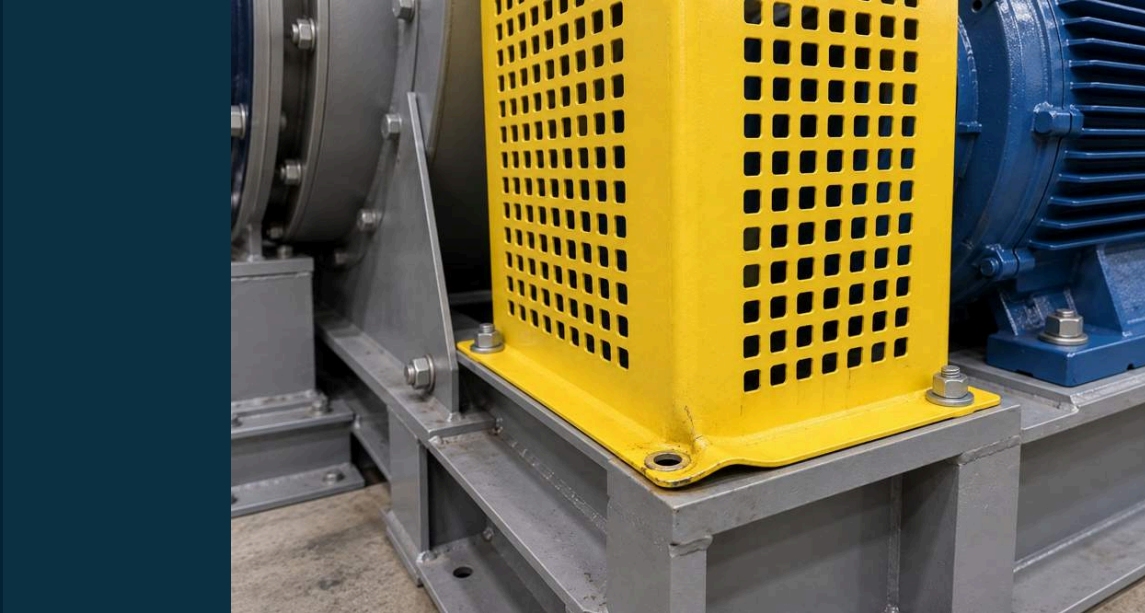
EVIDENCE 01 / Synthetic inspection photo · FAN-GRD-02

I checked the accessible surfaces closely. The front lower guard fixing is missing and the edge is slightly bent. The guard is still installed; I have not removed it. I recorded 6.2 mm/s RMS at the same pedestal point in mode M1, compared with 3.1 mm/s RMS on the prior visit. I did not open the bearing housing; internal bearing condition remains unverified.

Yellow perforated coupling guard is in place between the fan pedestal and motor, but the front lower base shows a missing fixing and a slightly deformed edge as reported by the technician. Elevated pedestal vibration (6.2 mm/s RMS, up from 3.1) raises concern beyond the guard itself.

Replace missing front-lower guard fixing and straighten bent edge; schedule vibration diagnostic on coupling/bearing before continued run.

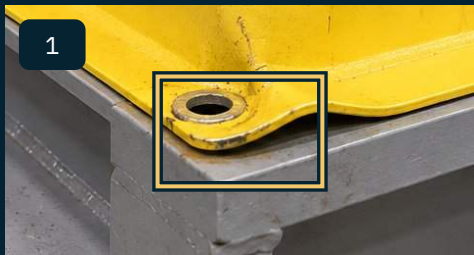
## 1 / Missing Front Fixing

WARNING

Empty bolt hole at front lower guard base

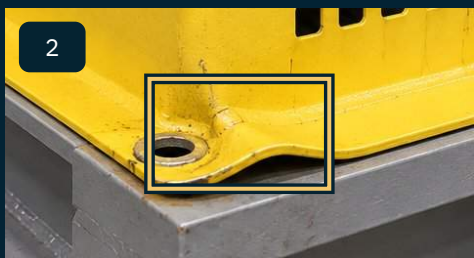
## 2 / Deformed Base Edge

WARNING

Slight bend along guard base flange

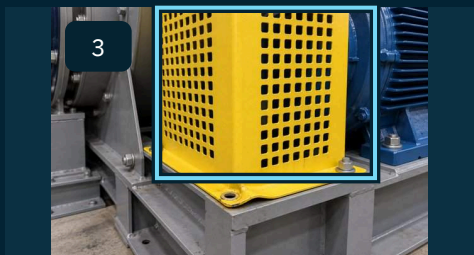
## 3 / Guard In Place

Perforated mesh intact, coupling enclosed

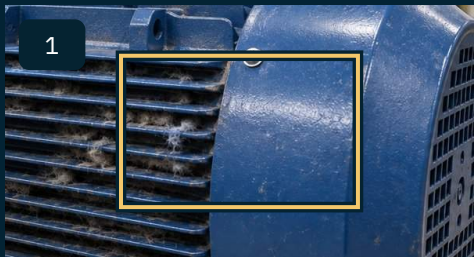
## 1 / Lint-Packed Fin Channels

WARNING

Dense fibrous debris bridging multiple cooling fin gaps

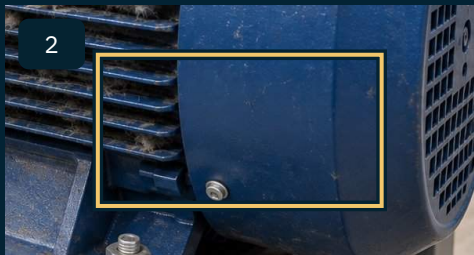
## 2 / Additional Fin Fouling

WARNING

Lint accumulation extends along lower fin rows

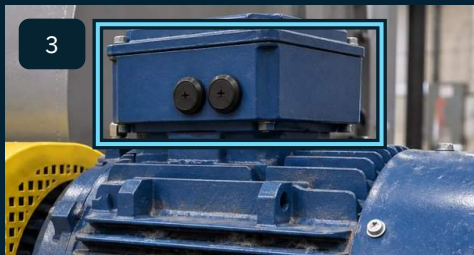
## 3 / Terminal Box Closed

Cover seated with fasteners in place

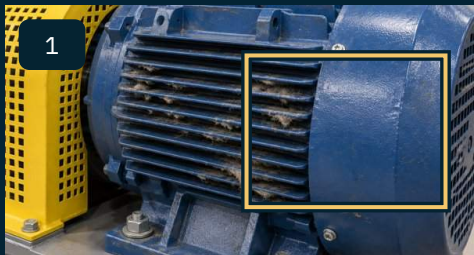
## 1 / Lint-Packed Fin Channels

WARNING

Heavy fibrous debris blocking motor cooling fins

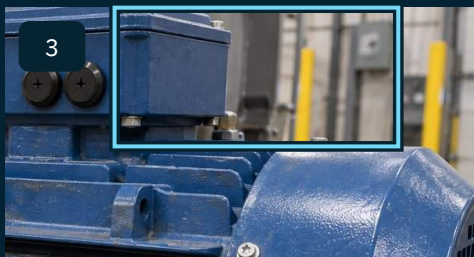
## 3 / Terminal Box Closed

Cover seated, gland plugs in place

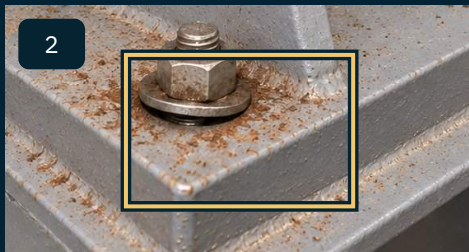
## 2 / Fretting Debris Halo

**WARNING**

Rust-colored oxide spread radially around fastener

Rust-colored fretting debris is spread radially around the front hold-down and across the pedestal top plate, consistent with relative micro-motion at the joint. [MEDIUM]

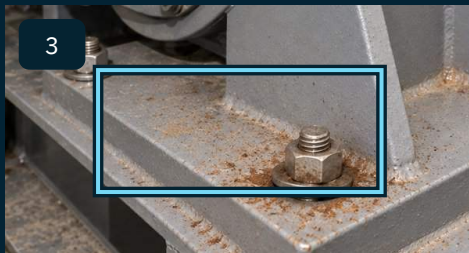
## 3 / Debris Trail On Plate

**INFO**

Fretting product distributed across pedestal top surface

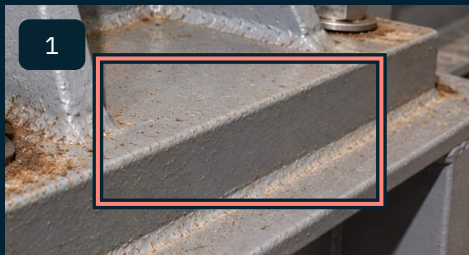
## 1 / Front Hold-Down Fretting

CRITICAL

Rust debris halo around lifted washer edge

Rust-colored fretting debris fanned across the pedestal top plate around the front hold-down bolt, consistent with micro-motion at the joint. [HIGH]

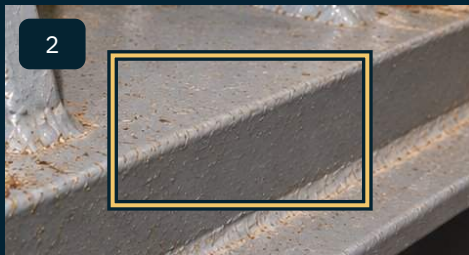
## 2 / Lifted Washer Edge

WARNING

Washer not fully seated on pedestal

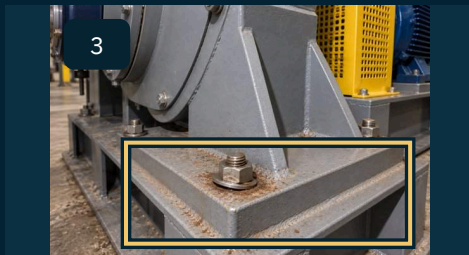
## 3 / Debris Migration Path

WARNING

Oxide debris spread across pedestal foot

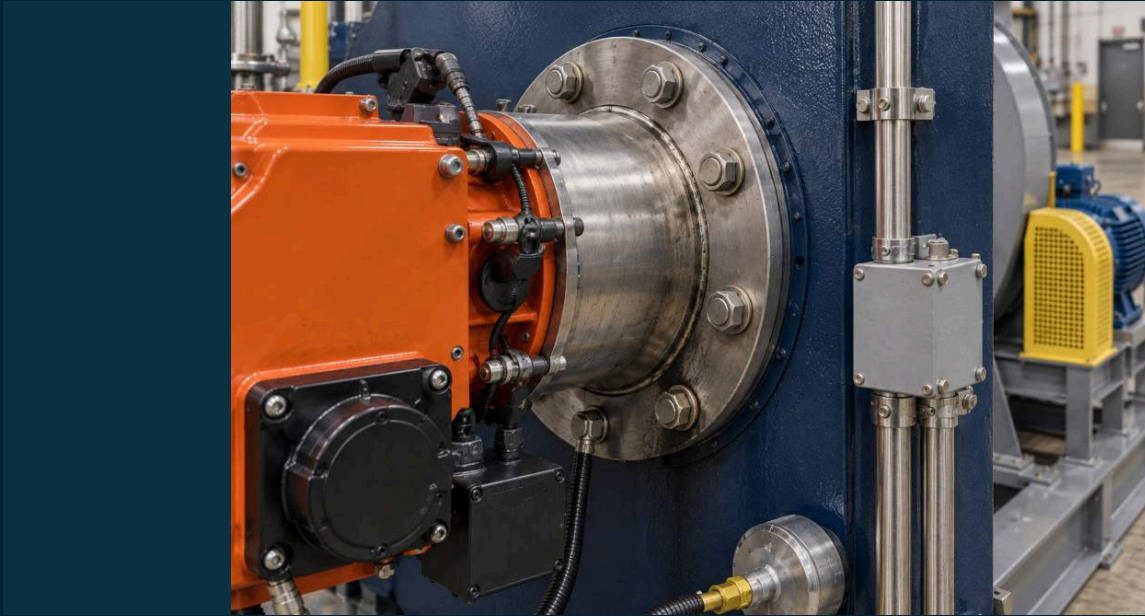
EVIDENCE 01 / Synthetic inspection photo · BRN-FLG-01

I photographed burner mounting flange. A soot-darkened track extends from the lower flange joint. One lower washer looks unevenly seated. I did not open the burner or establish combustion quality from the exterior photograph.

Burner mounting flange shows a soot-darkened track descending from the lower joint area and one lower fastener with an unevenly seated washer, consistent with the technician's observation. Exterior condition only; combustion quality not assessed.

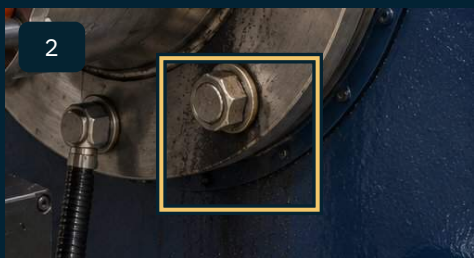
## 2 / Uneven Washer

WARNING

Lower fastener washer appears unevenly seated
