# ATLAS T-240

Wear and deterioration inspection

DEMO-001

10 Feb 2026

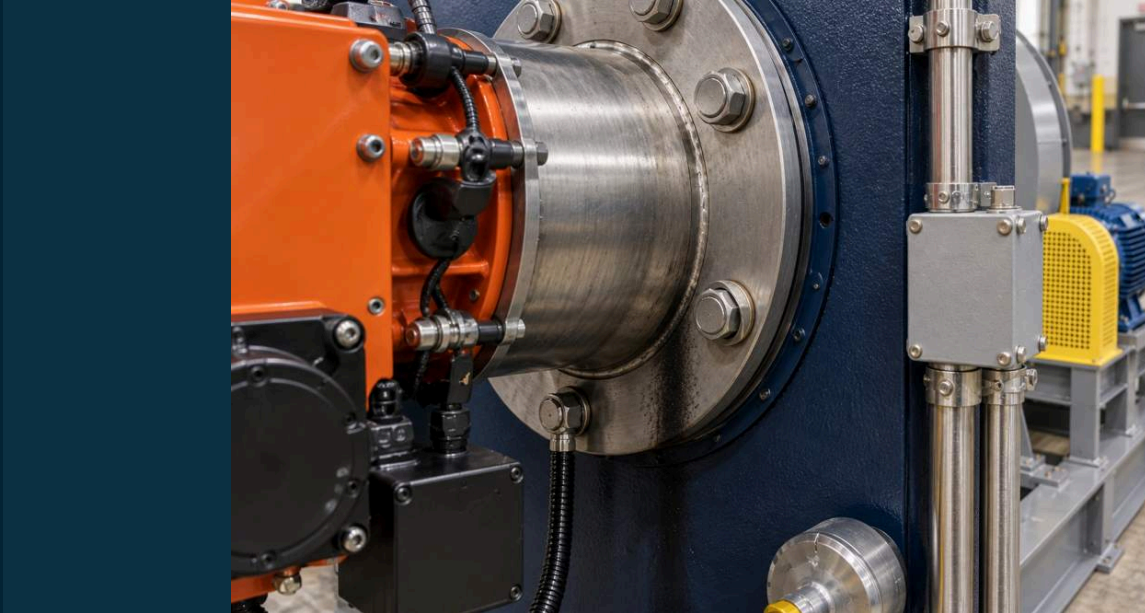
EVIDENCE 01 / Synthetic inspection photo · BRN-FLG-02

I checked the accessible surfaces closely. A soot-darkened track extends from the lower flange joint. One lower washer looks unevenly seated. I recorded the flame-signal display at 2.9 microamps in mode M1, below the 3.8 microamps recorded on the prior visit. I did not open the burner or establish combustion quality from the exterior photograph.

Burner mounting flange shows a soot-darkened track descending from the lower flange joint and one lower washer appears unevenly seated, consistent with the technician's on-site observations. Combustion quality is not assessed from the exterior image.

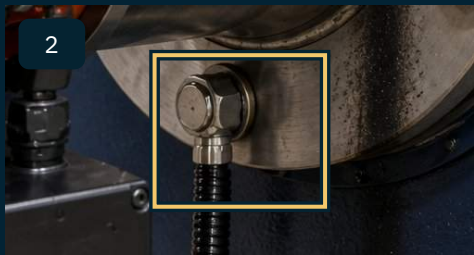
## 2 / Uneven Washer

WARNING

Lower fastener washer appears unevenly seated

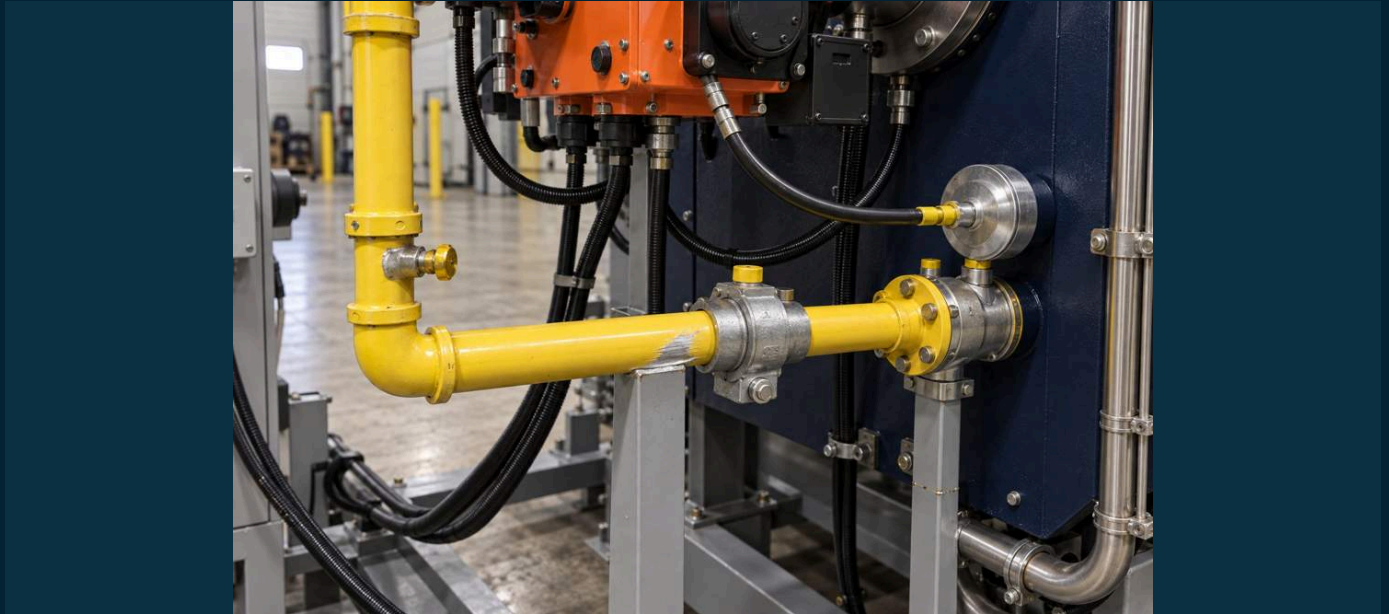
EVIDENCE 01 / Synthetic inspection photo · BRN-TUB-01

I photographed external burner tubing. The external tube is rubbing against its support edge, with a visible bright abrasion patch. I see no liquid droplet at the accessible fittings. I did not open the burner or establish combustion quality from the exterior photograph.

External yellow burner tubing shows a distinct bright abrasion patch where the pipe contacts its support edge; no liquid moisture is visible at accessible fittings.

Yellow horizontal burner tube exhibits a bright silver abrasion patch on its underside where it rests against the support crossmember, indicating ongoing rubbing wear through the paint layer. [MEDIUM]

Tubing routing places the pipe in direct hard contact with a metal support edge with no protective saddle or isolator visible at the wear point. [MEDIUM]

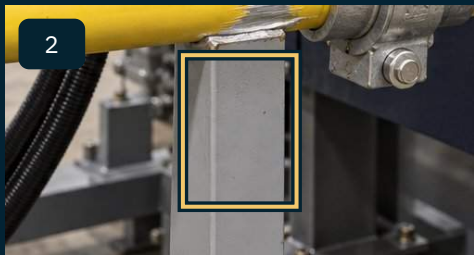
## 2 / Support Edge Contact

WARNING

Tube rests directly on unpadded support crossmember

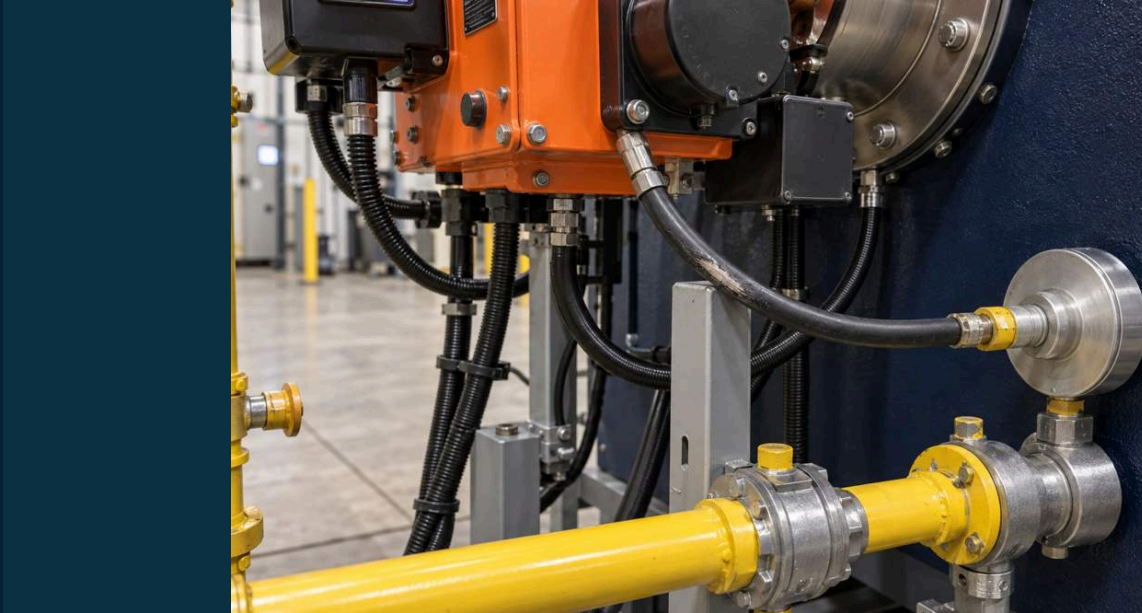
EVIDENCE 01 / Synthetic inspection photo · BRN-TUB-02

I checked the accessible surfaces closely. The external tube is rubbing against its support edge, with a visible bright abrasion patch. I see no liquid droplet at the accessible fittings. I recorded the flame-signal display at 2.9 microamps in mode M1, below the 3.8 microamps recorded on the prior visit. I did not open the burner or establish combustion quality from the exterior photograph.

External burner tubing shows a visible abrasion patch where a flexible hose contacts a support bracket edge. No moisture is visible at accessible fittings; technician-reported flame signal decline is noted but not assessable from the photo.

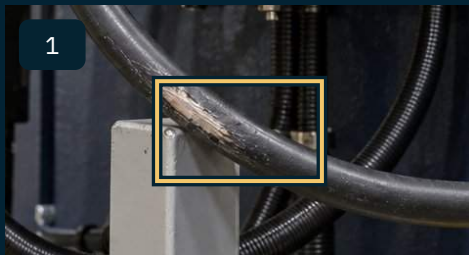
## 1 / Hose Abrasion Patch

WARNING

Bright wear mark where hose contacts bracket edge

Flexible black hose exhibits a bright abrasion/wear patch where it rides against the edge of a gray support bracket. [MEDIUM]

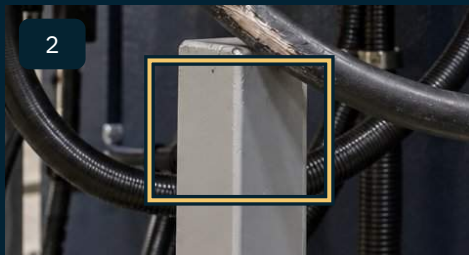
## 2 / Support Edge Contact

WARNING

Unsupported hose bearing on rigid bracket corner

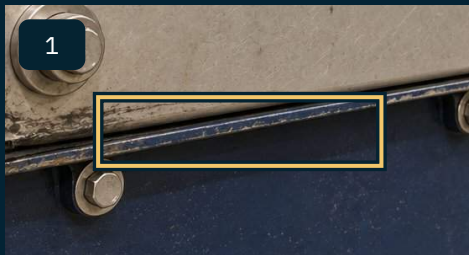
## 1 / Displaced Gasket Segment

WARNING

Extruded gasket material at lower hatch corner

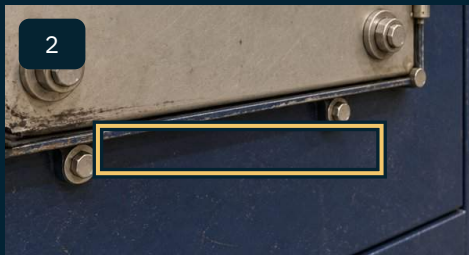
## 2 / Soot Track

WARNING

Dark deposit on metal below seal line

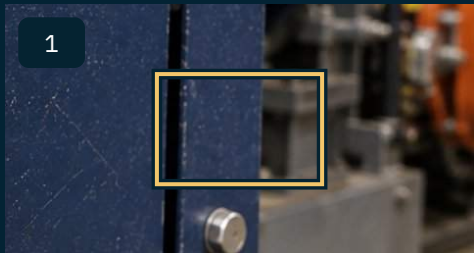
## 1 / Displaced Gasket Material

WARNING

Frayed seal protruding from hatch corner

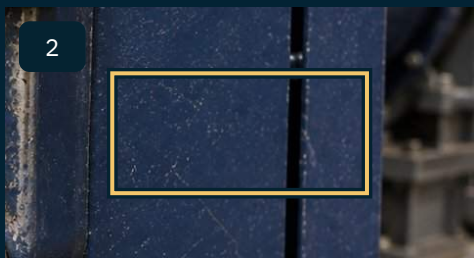
## 2 / Soot Track

WARNING

Dark leakage staining on hatch face

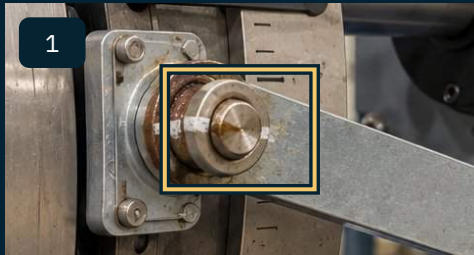
## 1 / Offset Witness Paint

WARNING

Witness mark misaligned across pivot fastener

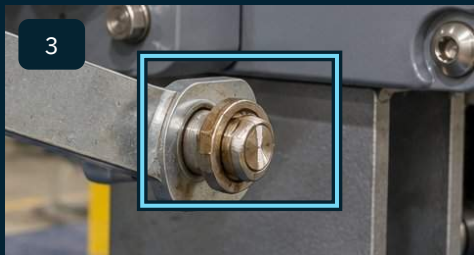
Brown oxidation/residue around driven pivot joint

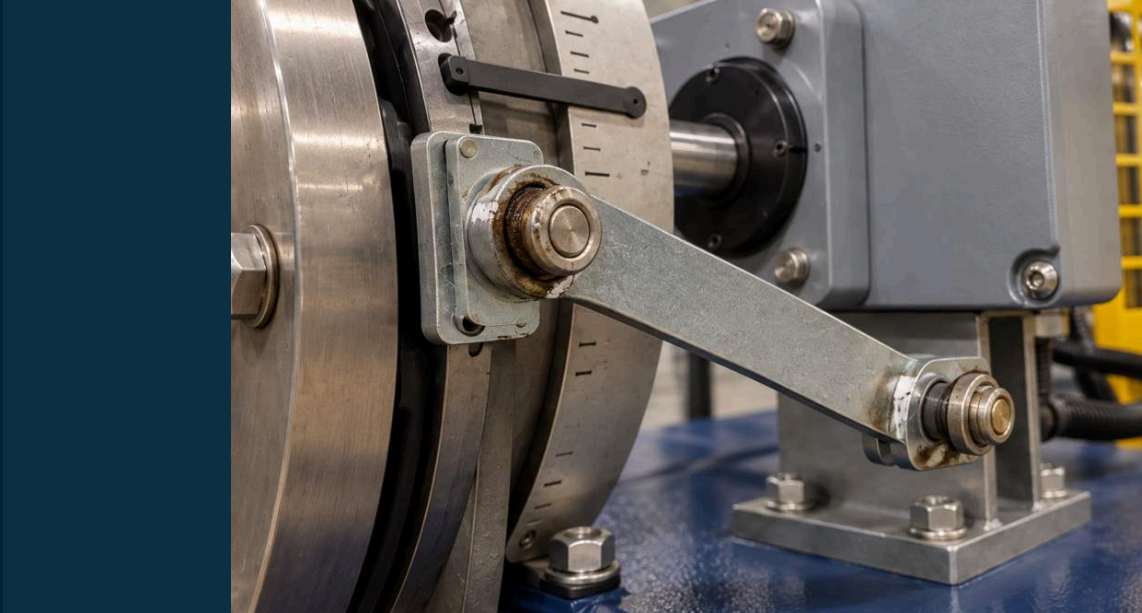
EVIDENCE 01 / Synthetic inspection photo · DMP-LNK-02

Actuator linkage arm is intact at both ends, but the driven-side pivot shows brown residue and misaligned witness paint, suggesting slippage or corrosion at the joint. Full travel and calibration cannot be confirmed from a still image.

Perform full-stroke travel and linkage calibration check; re-mark witness paint and inspect pivot bushing for wear.

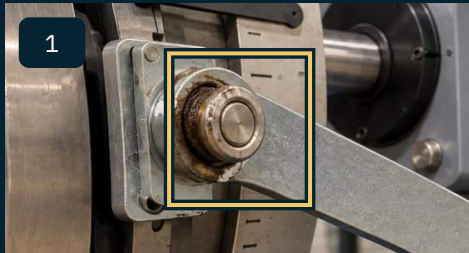
## 1 / Driven Pivot Residue

Brown residue and offset witness paint at pivot

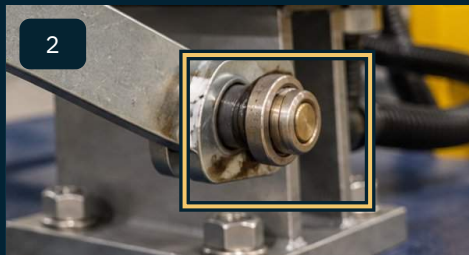
## 2 / Actuator Pivot Staining

Rust staining at actuator-end pivot joint

Actuator-end pivot also shows minor rust staining at the joint, though less pronounced than the driven end. [LOW]

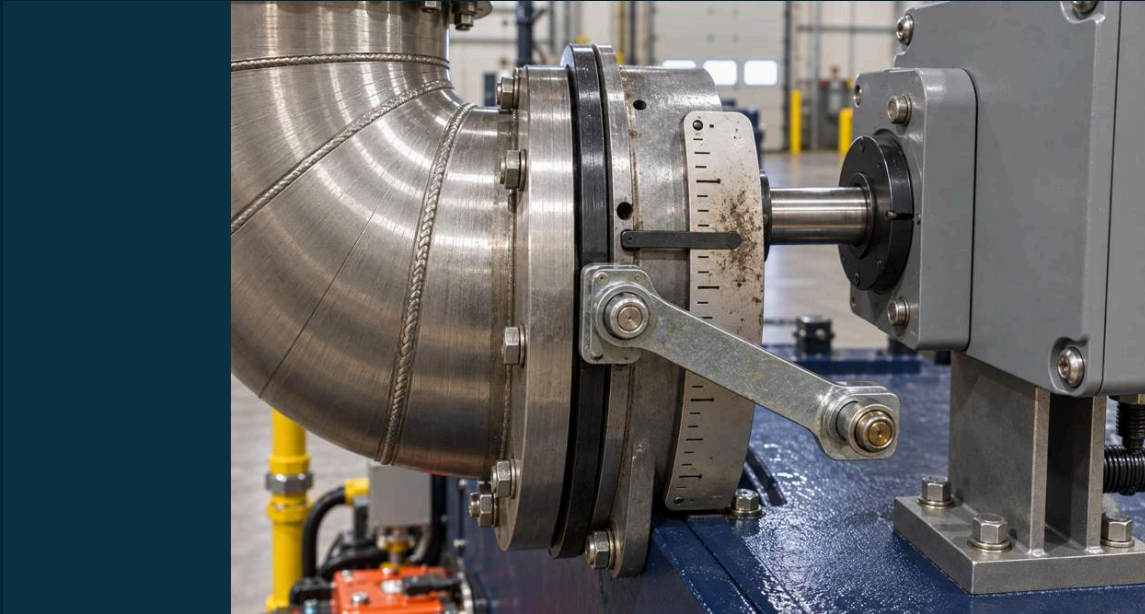
EVIDENCE 01 / Synthetic inspection photo · DMP-POS-01

I photographed position pointer. The scale has a worn dirty patch around its middle range. The pointer remains attached. The still photo does not establish full travel or calibration.

Position pointer and graduated scale are intact and attached, but the mid-range of the scale shows a worn, dirty patch that reduces legibility. The photograph alone cannot establish full travel or calibration.

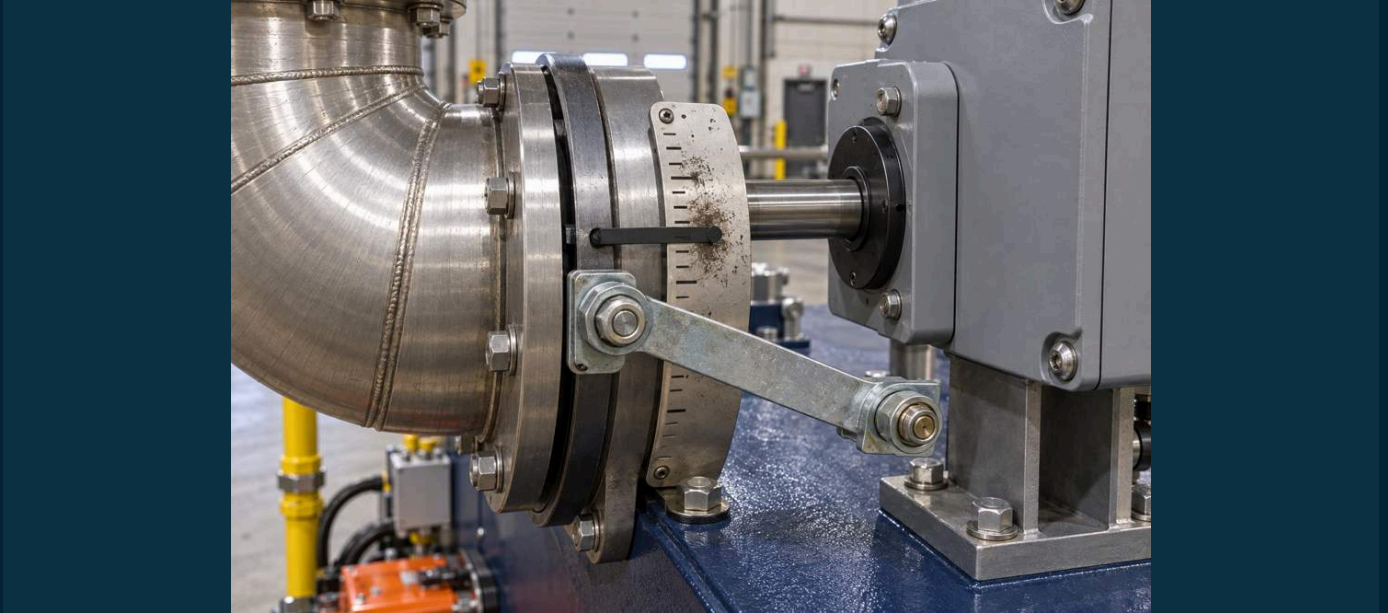
EVIDENCE 01 / Synthetic inspection photo · DMP-POS-02

I checked the accessible surfaces closely. The scale has a worn dirty patch around its middle range. The pointer remains attached. In mode M1 I recorded a 50% command and approximately 43% indicated position; I have requested a travel and linkage check. The still photo does not establish full travel or calibration.

Position pointer is attached and readable, but the scale shows a soiled/worn patch across its mid-range. Technician reports a command-vs-indicated discrepancy in M1 (50% commanded, ~43% indicated); photo alone does not establish calibration.

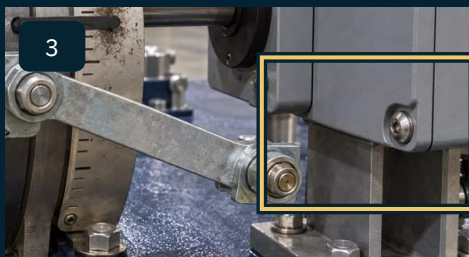
## 3 / Actuator Linkage Arm

Linkage to actuator; check for slack

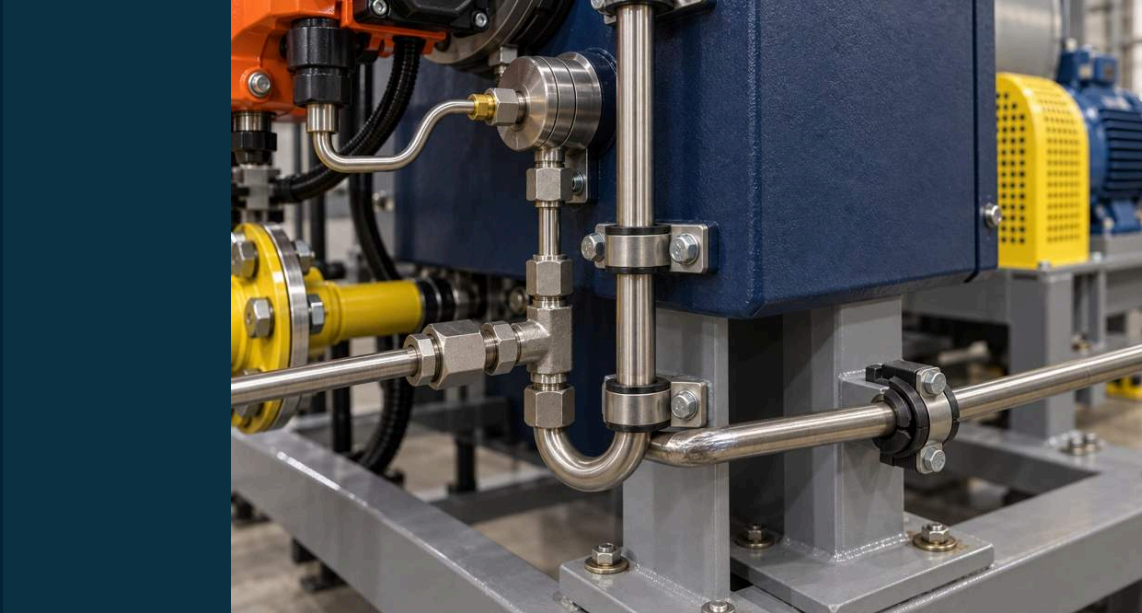
EVIDENCE 01 / Synthetic inspection photo · SNS-FIT-01

Tubing support liner adjacent to the fitting shows a split, and the stainless tube displays a polished contact/rub mark beside the clamp, indicating early mechanical wear at the support interface.

Replace split support liner, inspect tube wall thickness at rub mark, and re-secure clamp to eliminate motion.

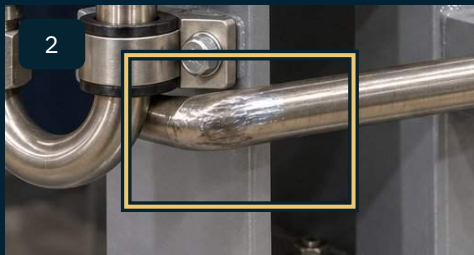
## 2 / Tube Polish Mark

Polished rub mark beside fitting from motion

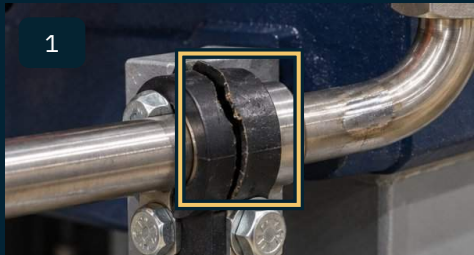
## 1 / Split Support Liner

Elastomeric clamp liner split at parting line

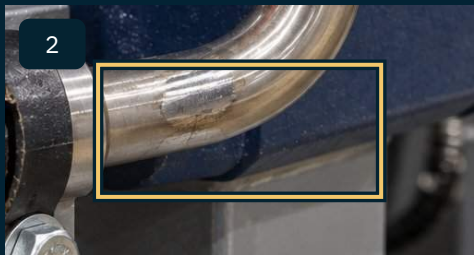
## 2 / Polished Rub Mark

Contact wear on tube beside elbow fitting

Polished contact mark on the stainless tube adjacent to the elbow fitting, consistent with rubbing/fretting. [MEDIUM]

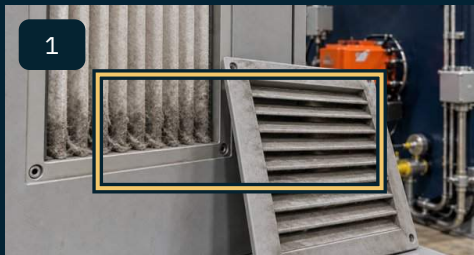
## 1 / Heavy Lint Loading

Dense gray lint matted across lower filter pleats

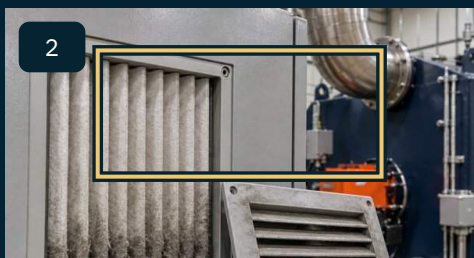
## 2 / Pleat Face Fouling

Upper pleats also coated, reducing effective area

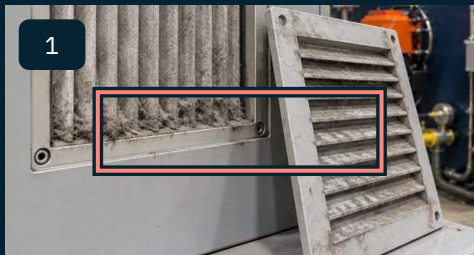
## 1 / Heavy Lint Loading

Matted gray lint bridging pleats at lower edge

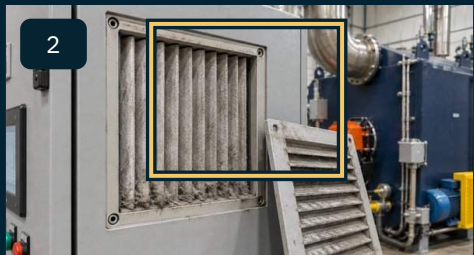
## 2 / Loaded Pleat Faces

Dust film across full filter face reduces airflow

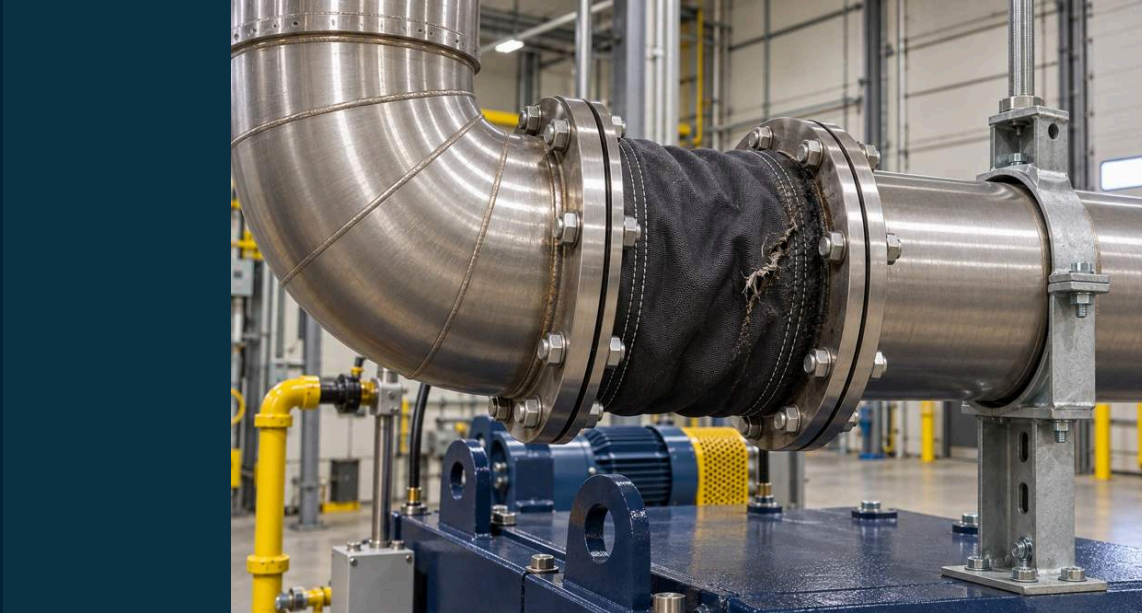
EVIDENCE 01 / Synthetic inspection photo · DUC-JNT-01

I photographed flexible connector and clamps. The outer fabric fold is split with exposed fibers and dark residue beside the clamp. The rear underside is outside this camera view. I did not perform a leak test or inspect the concealed inner fabric.

Schedule flexible connector replacement; inspect concealed underside and perform leak test before continued service.

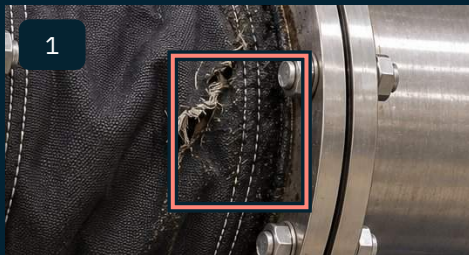
## 1 / Torn Fabric Fold

Split fold with exposed frayed fibers

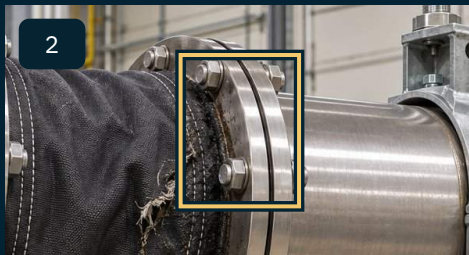
## 2 / Dark Residue Track

Dark staining beside downstream clamp face

Dark residue/tracking visible on the fabric adjacent to the clamp, suggesting past leakage or contamination. [HIGH]

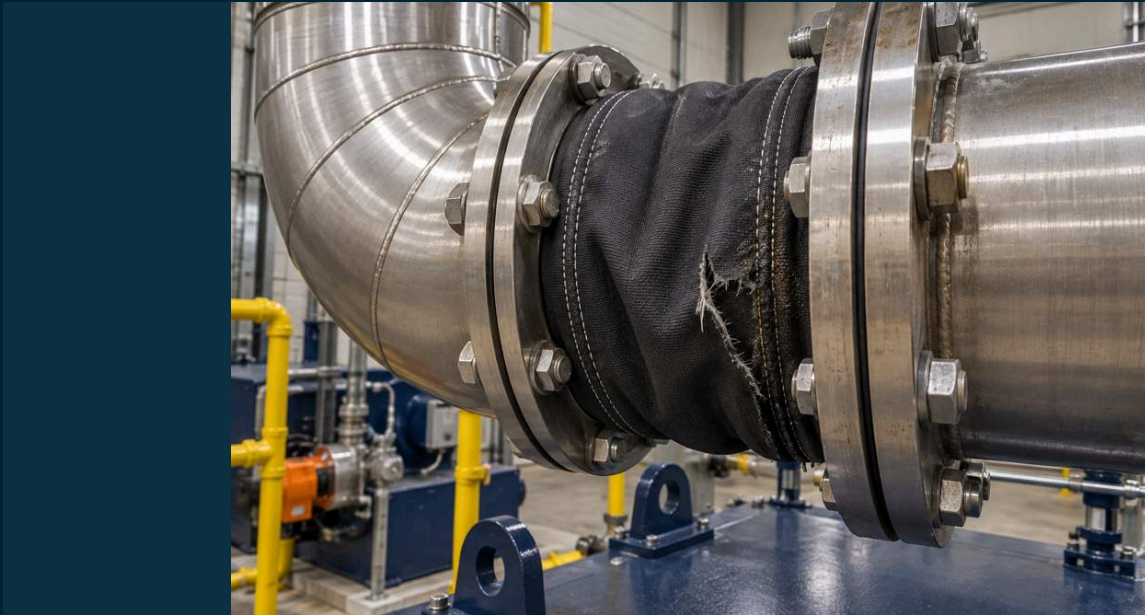
EVIDENCE 01 / Synthetic inspection photo · DUC-JNT-02

I checked the accessible surfaces closely. The outer fabric fold is split with exposed fibers and dark residue beside the clamp. The rear underside is outside this camera view. I did not perform a leak test or inspect the concealed inner fabric.

Dark streak/residue tracks down the fabric toward the right-hand flange, suggesting leakage or contamination past the seal. [HIGH]

Isolate and schedule replacement of the flexible connector; inspect concealed underside and perform leak test before return to service.

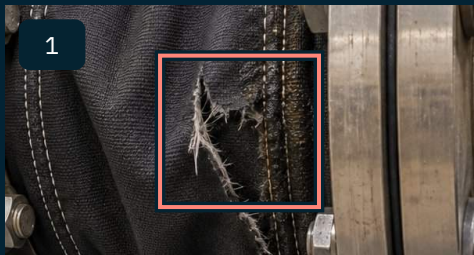
## 1 / Torn Fabric Fold

CRITICAL

Split outer ply with exposed frayed fibers

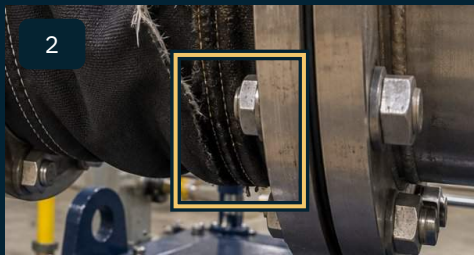
## 2 / Dark Residue Track

WARNING

Streak toward flange indicates leakage path

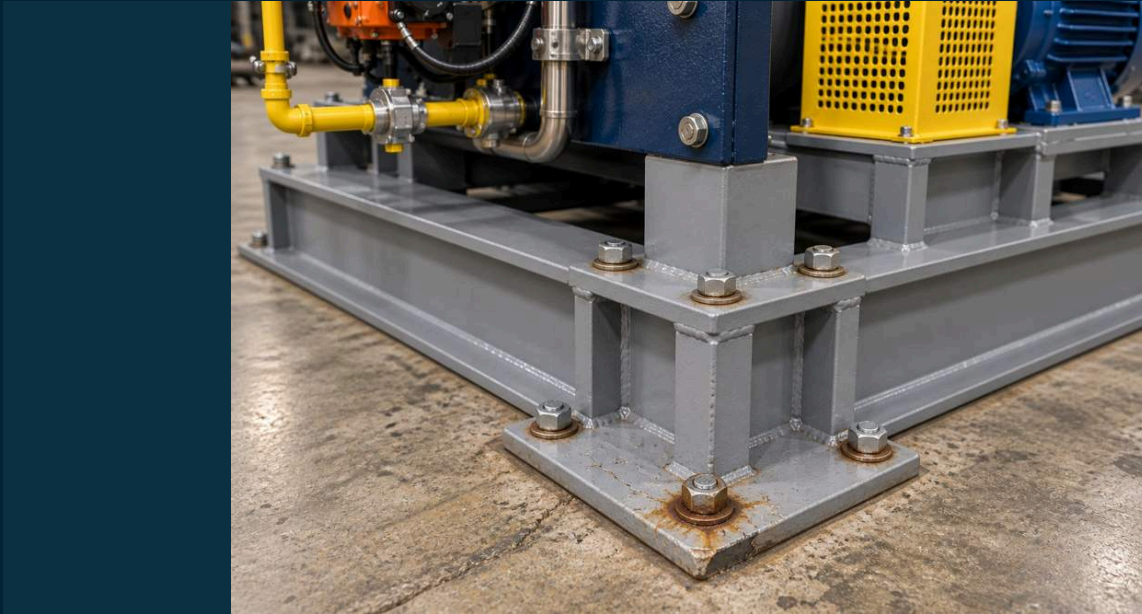
EVIDENCE 01 / Synthetic inspection photo · FRM-ANC-01

I photographed skid base anchors. The anchor washer is rust stained and the adjacent paint is flaking. There is a small chipped area at the floor contact edge. I did not proof-test the anchors or establish their load capacity.

Skid base anchor plate shows rust staining radiating from the anchor washer with associated paint discoloration and a chipped edge at the floor contact point. Cosmetic/surface degradation is visible; anchor capacity was not assessed.

Clean and touch up affected area; monitor anchor washer for progressive corrosion.

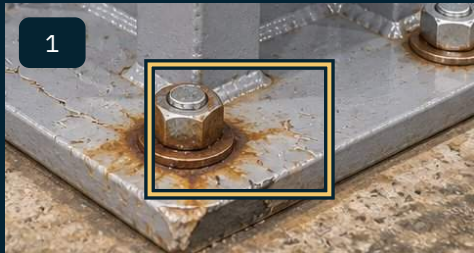
## 1 / Rust-Stained Anchor Washer

WARNING

Corrosion staining radiating from anchor washer

Rust staining emanates from the front anchor washer across the base plate paint. [LOW]

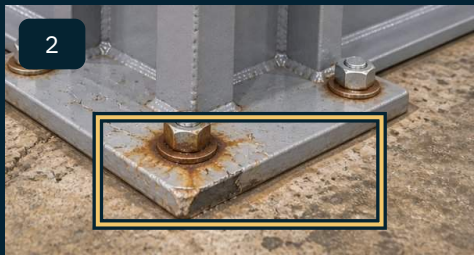
## 2 / Paint Flaking

WARNING

Coating degradation adjacent to anchor bolt

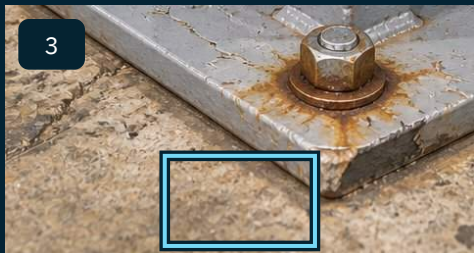
## 3 / Chipped Plate Edge

INFO

Small chip at floor contact edge

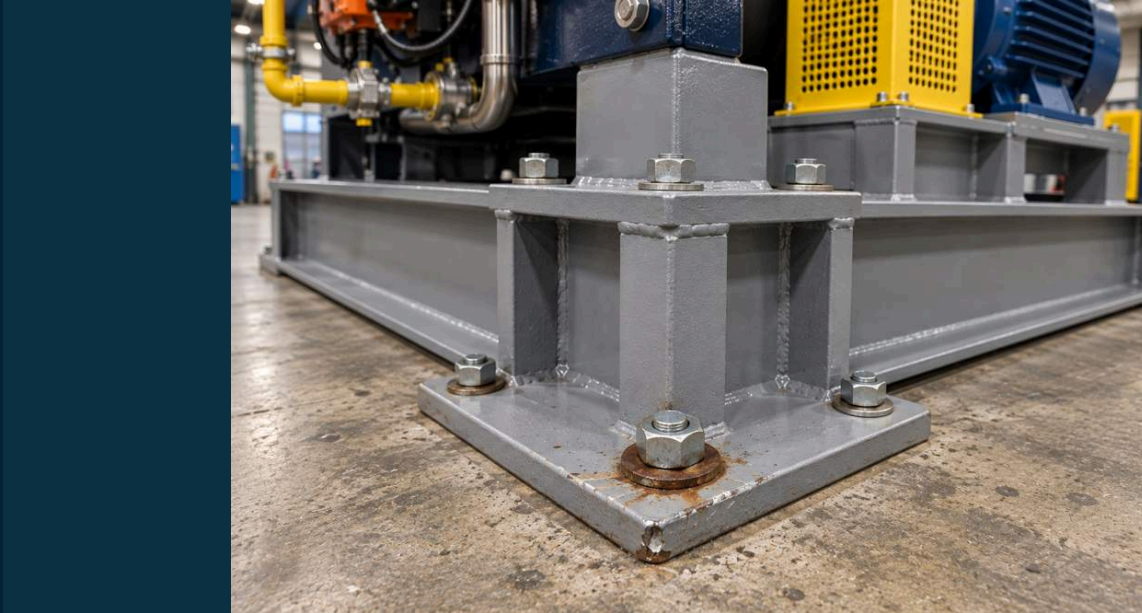
EVIDENCE 01 / Synthetic inspection photo · FRM-ANC-02

I checked the accessible surfaces closely. The anchor washer is rust stained and the adjacent paint is flaking. There is a small chipped area at the floor contact edge. I did not proof-test the anchors or establish their load capacity.

Skid base anchor at the near corner shows rust staining around the washer and localized paint flaking with a small chip at the floor contact edge. Hardware appears seated; no proof-test performed.

Clean and re-coat affected anchor area to arrest corrosion; monitor at next inspection.

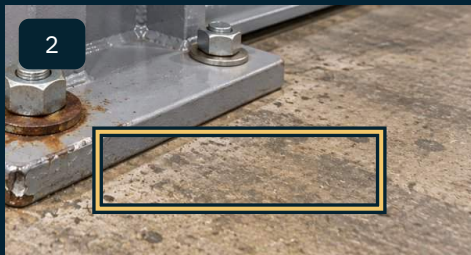
## 2 / Paint Flaking

WARNING

Coating lifting adjacent to anchor washer

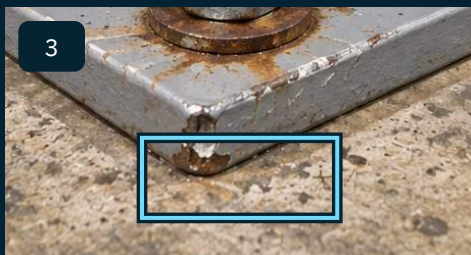
## 3 / Edge Chip

INFO

Small chip at base plate floor edge

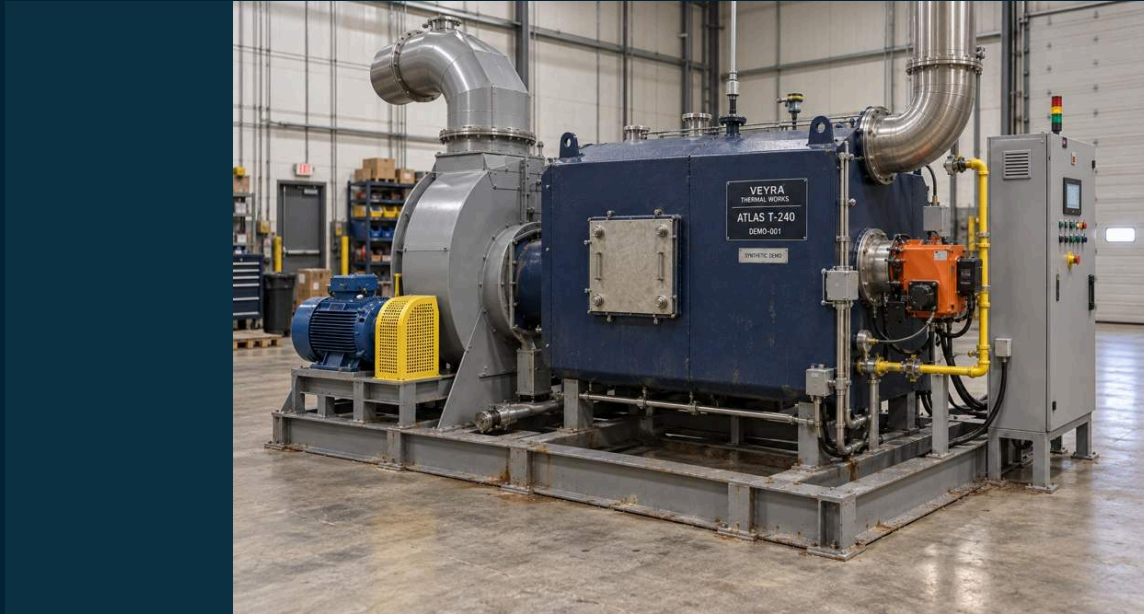
EVIDENCE 01 / Synthetic inspection photo · item-overall-commissioning-baseline

I checked the accessible surfaces closely. I identified DEMO-001 from the machine label. Dust, chipped paint and local rust staining are visible on the lower frame; all major assemblies remain installed. This overview does not replace the individual component checks recorded below.

Unit is identifiable as ATLAS T-240 (DEMO-001) with overall silhouette and major assemblies matching the commissioning reference. Lower frame shows dust accumulation, chipped paint, and localized rust staining consistent with the technician's observation.

Log cosmetic frame corrosion for future touch-up; proceed with individual component checks.

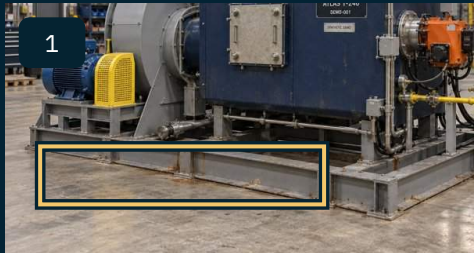
## 1 / Frame Rust Staining

WARNING

Localized rust and chipped paint on skid base

Lower structural frame shows chipped paint and localized rust staining, particularly along base beams and skid edges. [LOW]

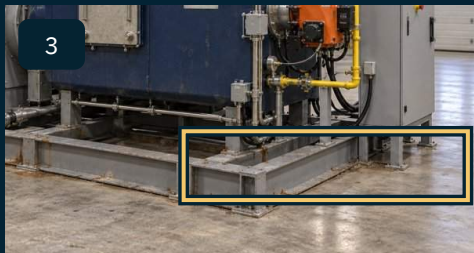
## 3 / Lower Beam Corrosion

WARNING

Rust bloom along right-side frame member
